Seal Rock RFPD - Bayshore Station

FEMA 154 Rapid Visual Screening Score Card

Rapid Visual Screening - Senate Bill #2 - Seismic Needs Assessment
Oregon Department of Geology and Mineral Industries

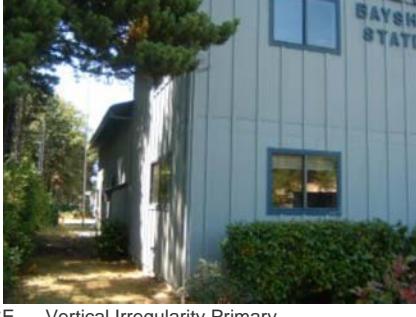
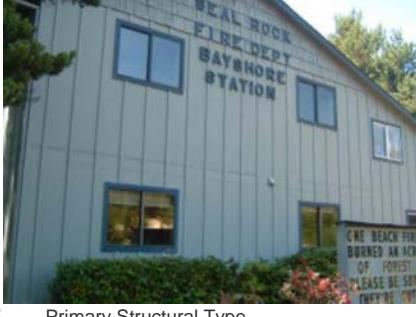
SE	Vertical Irregularity Primary	E	Primary Structural Type
