Samaritan North Lincoln Hospital - Lincoln City

Linc_hos02A

FEMA 154 Rapid Visual Screening Score Card

Rapid Visual Screening - Senate Bill #2 - Seismic Needs Assessment
Oregon Department of Geology and Mineral Industries

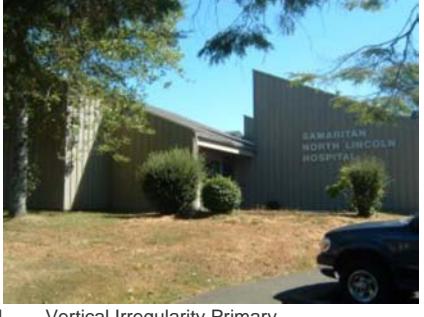
Enrollment	Year Built (Field Verified)	Year Built (Alt. Source)	Est. Decade Built
		1980	1980
Total Area (square ft)	Number of Stories	Basement	Pounding Potential
10234	1	No	No
Plan Irregularities		Vertical Irregularities	
Reentrant Corners: Other		Steps in Elevation View: Very Irregular Changes	
None		None	
None		None	
Falling Hazards		Poor Conditions	
None		None	
None		None	
None		None
