Yaquina View Elementary School

Linc_sch08A

FEMA 154 Rapid Visual Screening Score Card

Rapid Visual Screening - Senate Bill #2 - Seismic Needs Assessment
Oregon Department of Geology and Mineral Industries

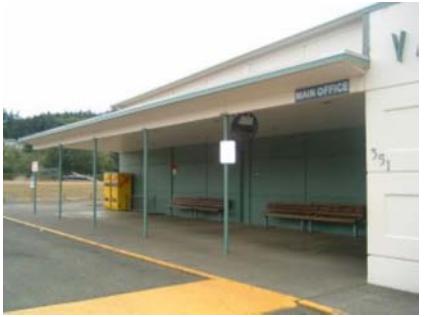
NW Falling Hazard covered walkway at entrance	NW General Site	W Plan Irregularity Primary steps in elevation also

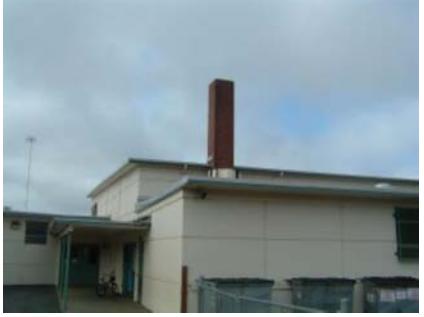
S General Site	N Falling Hazard	NE General Site

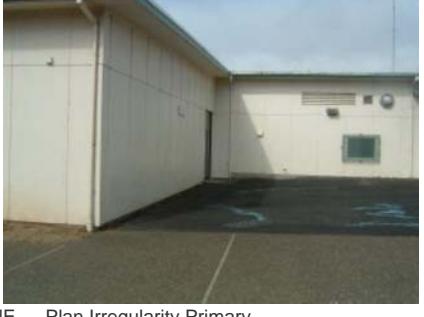
NE Plan Irregularity Primary
