Newport High School - East

Linc_sch09A

FEMA 154 Rapid Visual Screening Score Card

Rapid Visual Screening - Senate Bill #2 - Seismic Needs Assessment
Oregon Department of Geology and Mineral Industries

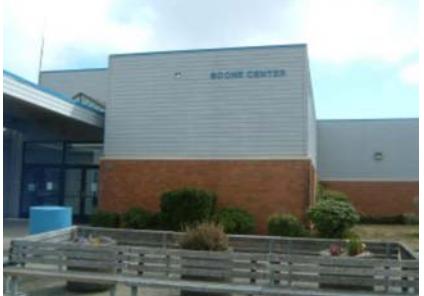
W General Site Boone Center - 1994 Addition

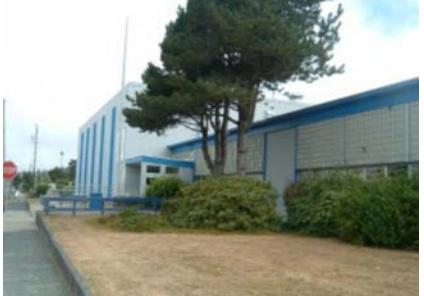
SW General Site

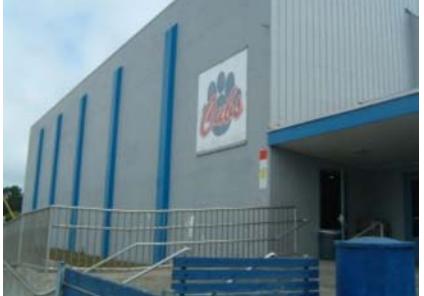
W Primary Structural Type

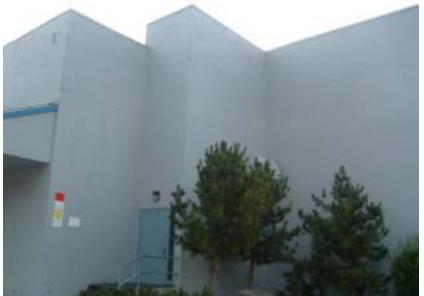
NW Plan Irregularity Primary step in elevation also

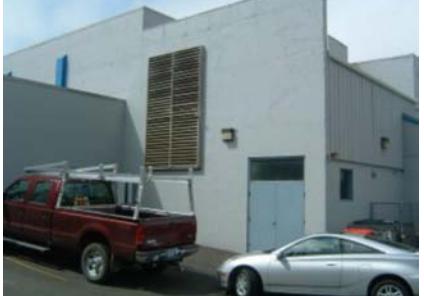
NE Primary Structural Type secondary and tertiary structural types also

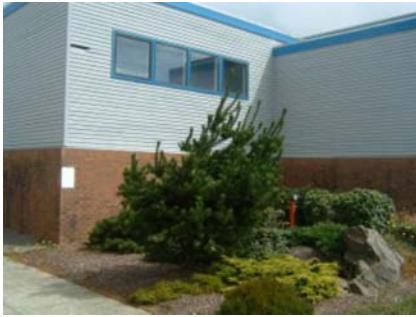
S Plan Irregularity Primary
