Toledo High School

Lincoln County SD

FEMA 154 Rapid Visual Screening Score Card

Rapid Visual Screening - Senate Bill #2 - Seismic Needs Assessment
 Oregon Department of Geology and Mineral Industries

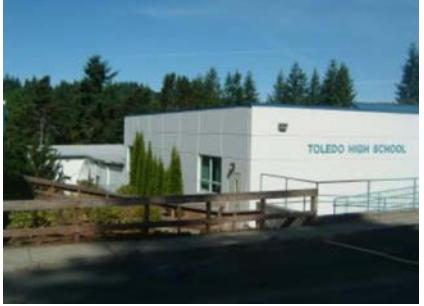
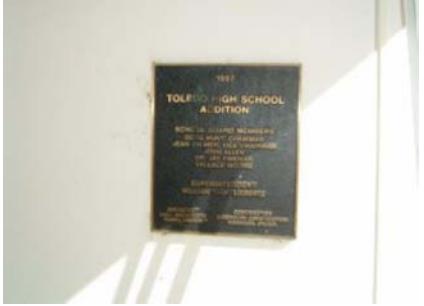
SE Vertical Irregularity Secondary reentrant corner also		S Field Verified Year Built

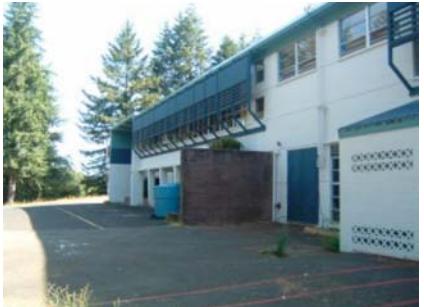
W Number of Stories

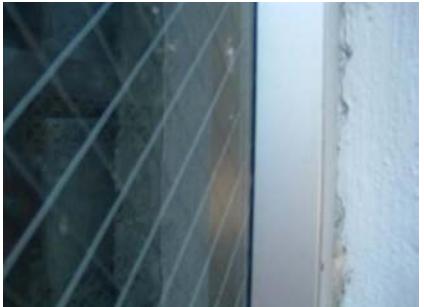
W Primary Structural Type

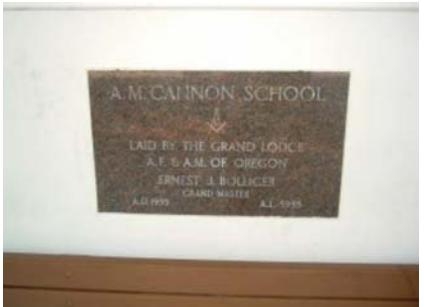
W Field Verified Year Built 1955

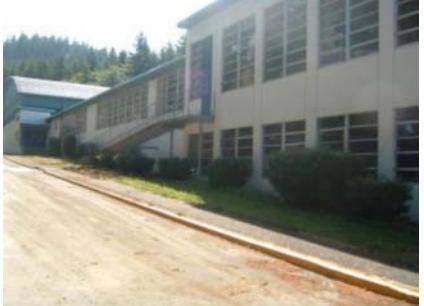
N Vertical Irregularity Primary

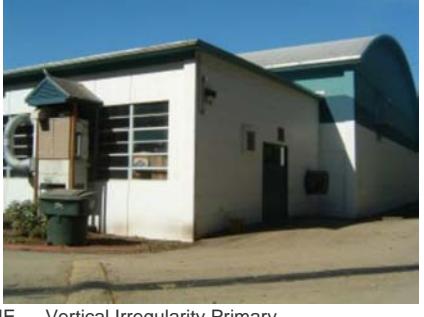
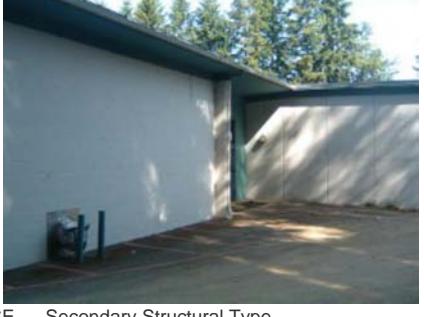
NE Vertical Irregularity Primary reentrant corner also		SE Secondary Structural Type tertiary structural type and reentrant corner also	
		S Number of Stories built on slope also
