Waldport High School

Linc_sch12A

FEMA 154 Rapid Visual Screening Score Card

Rapid Visual Screening - Senate Bill #2 - Seismic Needs Assessment
Oregon Department of Geology and Mineral Industries

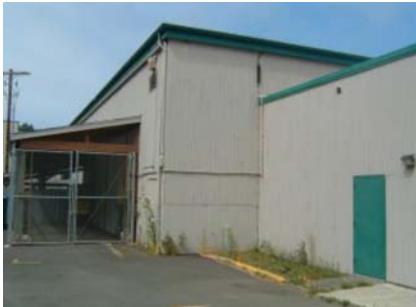
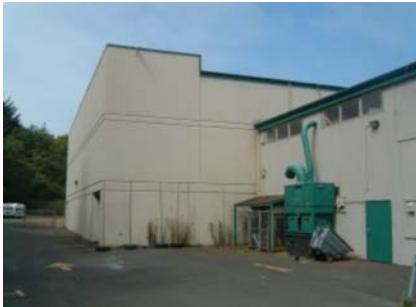
E Plan Irregularity Primary		E Vertical Irregularity Secondary reentrant corner also

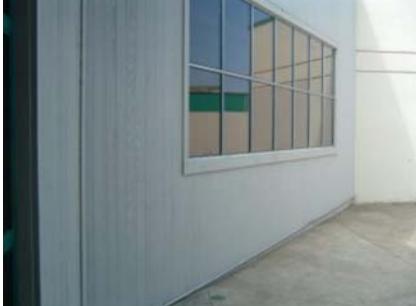
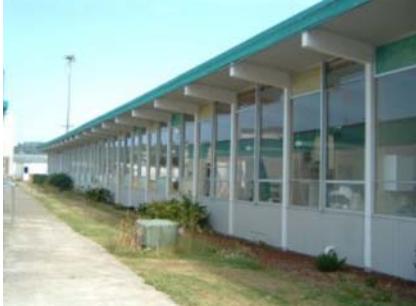
NE Plan Irregularity Tertiary actually 4th level of plan irregularity - ran out of labels. This is a non-parallel LFR system.		W Plan Irregularity Tertiary eccentric stiffness: torsion
