Eddyville Charter School

Lincoln County SD

FEMA 154 Rapid Visual Screening Score Card

Rapid Visual Screening - Senate Bill #2 - Seismic Needs Assessment
Oregon Department of Geology and Mineral Industries

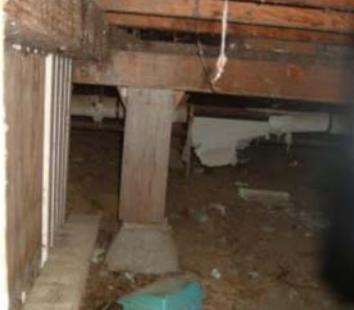
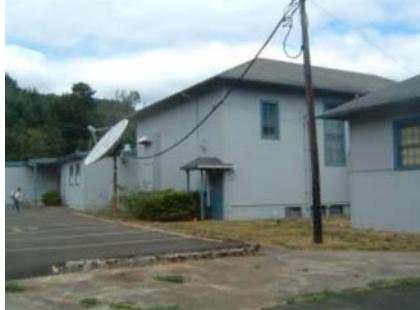
E Vertical Irregularity Tertiary		SE Vertical Irregularity Secondary reentrant corners also. Partial basement?	
		SE Vertical Irregularity Primary reentrant corners also

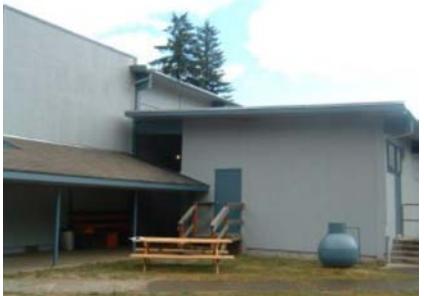
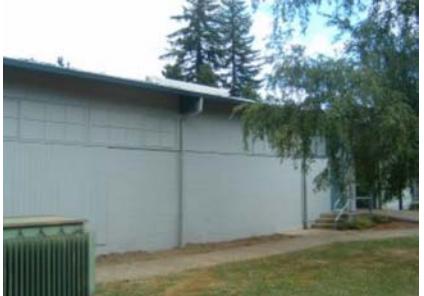
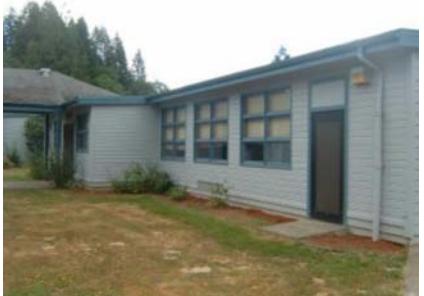
SW Plan Irregularity Primary step in elevation also		S Primary Structural Type secondary structural type also	N Plan Irregularity Primary
