Siletz Valley School

Lincoln County SD

FEMA 154 Rapid Visual Screening Score Card

Rapid Visual Screening - Senate Bill #2 - Seismic Needs Assessment
Oregon Department of Geology and Mineral Industries

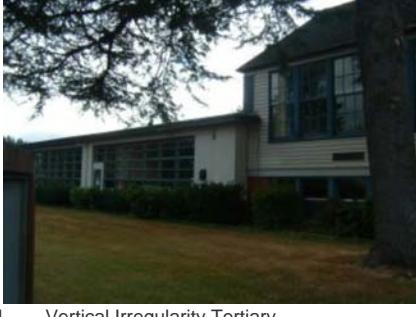
N Vertical Irregularity Tertiary out-of-plane offset also		NW Vertical Irregularity Primary reentrant corner also

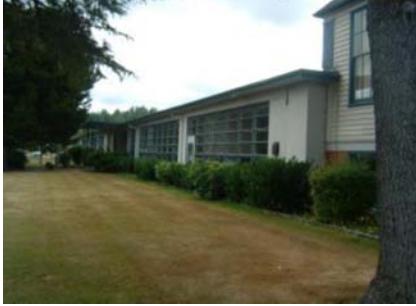
N Vertical Irregularity Primary out-of-plane lateral system as well

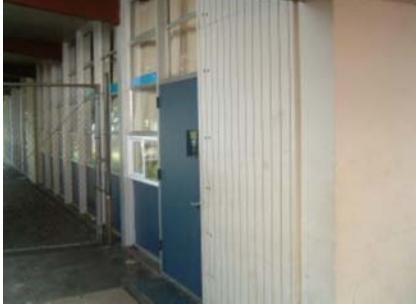
NW Plan Irregularity Primary primary and secondary structural types

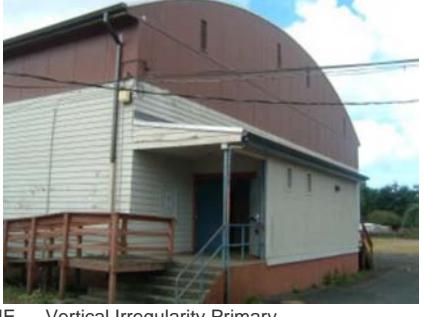
NE Vertical Irregularity Primary reentrant corner also at entryway		SW Plan Irregularity Primary step in elevation also at the locker room addition

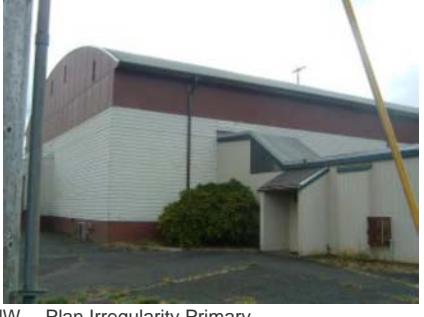
NW Plan Irregularity Primary step in elevation also at locker room addition

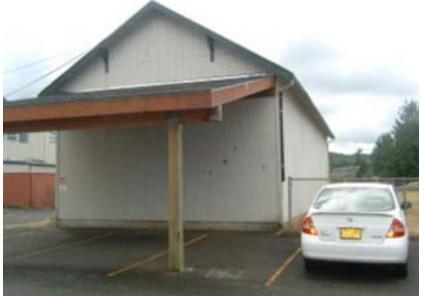
NW Primary Structural Type
