# Newport High School - West

Linc\_sch22A

Rapid Visual Screening - Senate Bill #2 - Seismic Needs Assessment  
Oregon Department of Geology and Mineral Industries

Linc\_sch22B

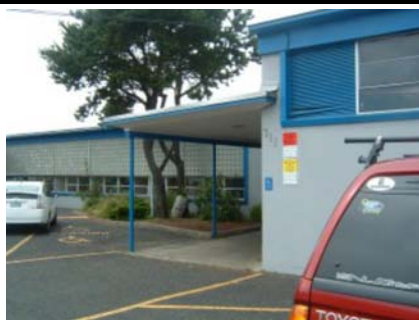
E Plan Irregularity Primary

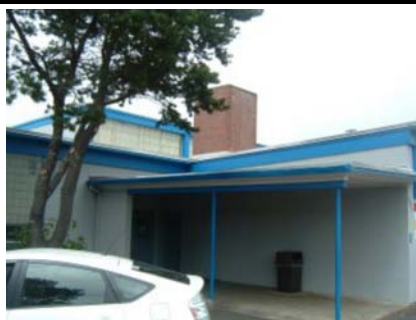
SE Falling Hazard  
reinforced chimney?  
Reentrant corner  
steps in elevation

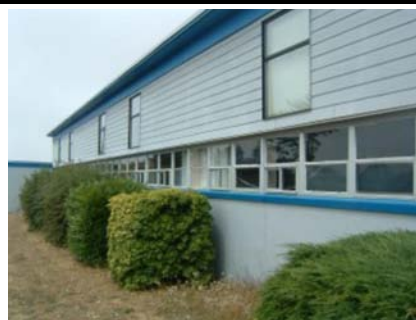
E General Site

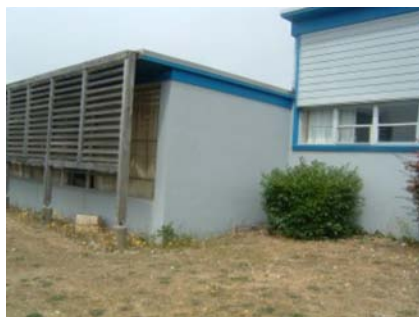
SE Plan Irregularity Primary

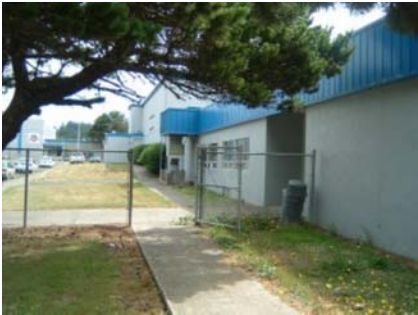
N General Site
