# Science and Technology

Linn-Benton CC

## FEMA 154 Rapid Visual Screening Score Card

Rapid Visual Screening - Senate Bill #2 - Seismic Needs Assessment  
Oregon Department of Geology and Mineral Industries

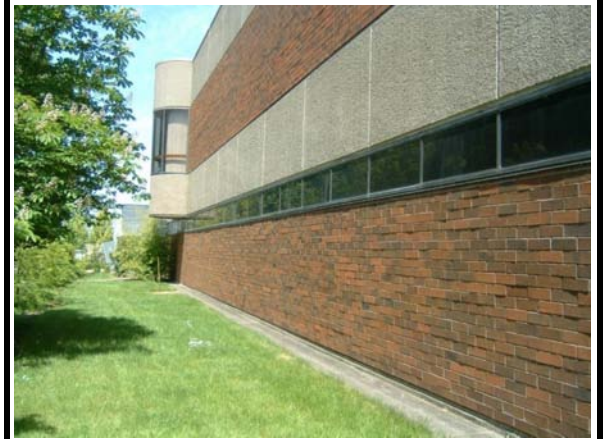
Seismicity Zone: High

| | Type | Basic Score | Vert Irreg | Plan Irreg | Pre-Code | Post-Bench | Soil C | Soil D | Soil E | RVS Score |
|---|---|---|---|---|---|---|---|---|---|---|
| Primary | C1 | 2.5 | -1.5 | -0.5 | 0 | 0 | 0 | -0.6 | 0 | -0.1 |

-0.1

Very High (100%)
