Service Center

Linn-Benton CC

Linn_coc07A

Rapid Visual Screening - Senate Bill #2 - Seismic Needs Assessment
Oregon Department of Geology and Mineral Industries

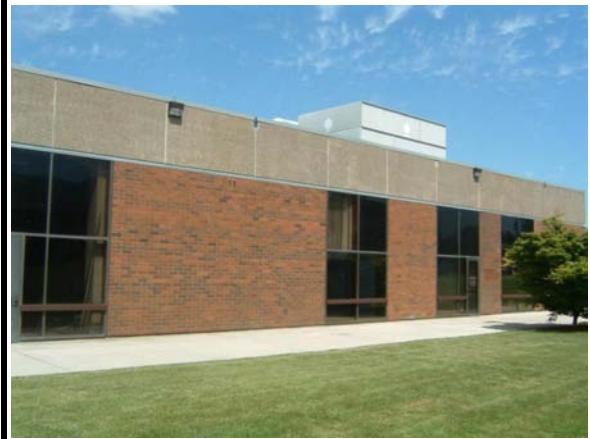
Type	Basic Score	Vert Irreg	Plan Irreg	Pre-Code	Post-Bench	Soil C	Soil D	Soil E	RVS Score
Primary	C1	2.5	-1.5	-0.5	0	0	0	-0.6	0	-0.1
Secondary		0	0	0	0	0	0	0	0	0
Tertiary		0	0	0	0	0	0	0	0	0

Final Type	Final Score
C1	-0.1

Very High (100%)
