# Student Union Building

Linn-Benton CC

## FEMA 154 Rapid Visual Screening Score Card

Rapid Visual Screening - Senate Bill #2 - Seismic Needs Assessment  
Oregon Department of Geology and Mineral Industries

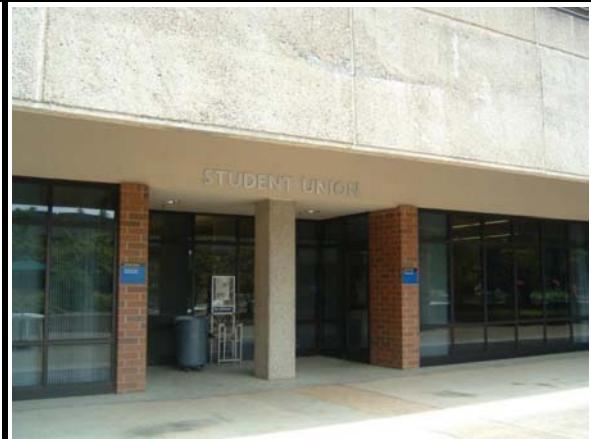
Seismicity Zone: High

Type	Basic Score	Vert Irreg	Plan Irreg	Pre-Code	Post-Bench	Soil C	Soil D	Soil E	RVS Score
Primary	C1	2.5	-1.5	-0.5	0	0	0	-0.6	0	-0.1
Secondary		0	0	0	0	0	0	0	0	0
Tertiary		0	0	0	0	0	0	0	0	0

Final Type	Final Score
C1	-0.1

Very High (100%)
