## Linn-Benton CC

Linn\_coc10A

## FEMA 154 Rapid Visual Screening Score Card

Rapid Visual Screening - Senate Bill #2 - Seismic Needs Assessment  
Oregon Department of Geology and Mineral Industries

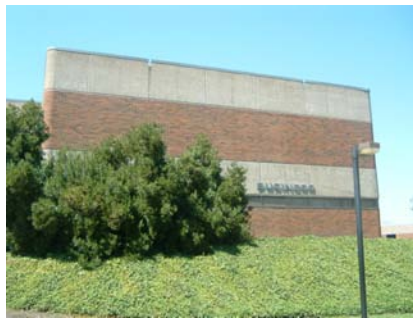
| Other: Brick Veneer | None |

E Falling Hazard

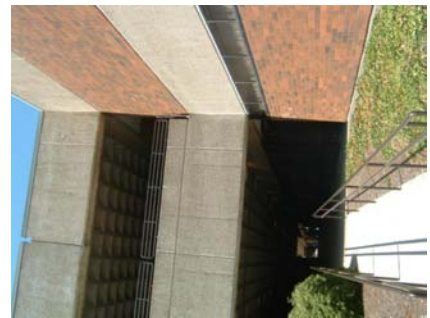
| Reentrant Corners: Other (Adjacent Build/Entity) | None |

SE Plan Irregularity Primary
