# Lebanon Fire District Station 33

Linn\_fir01A

## FEMA 154 Rapid Visual Screening Score Card

Rapid Visual Screening - Senate Bill #2 - Seismic Needs Assessment  
Oregon Department of Geology and Mineral Industries

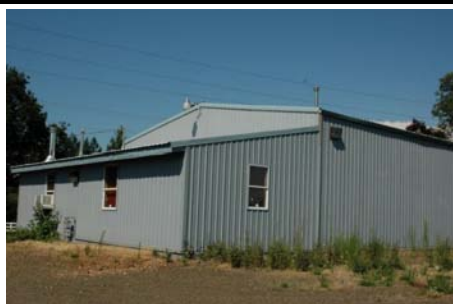
SW Vertical Irregularity Primary
