Halsey-Shedd RFPD

Linn_fir03A

Building Type Fire - RFPD	County Linn	
Street 740 W 2nd		
City Halsey	State OR	Zip 97348
Latitude 44.38358	Longitude 123.10948	
Tracking Code RVS in 2006	Inspection Date 7/7/2006

FEMA 154 Rapid Visual Screening Score Card

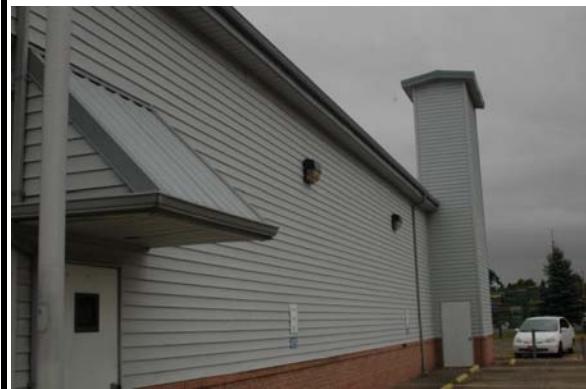
Type	Basic Score	Vert Irreg	Plan Irreg	Pre-Code	Post-Bench	Soil C	Soil D	Soil E	RVS Score
Primary	W2	3.8	-2	0	0	0	0	-0.8	0	1
Secondary		0	0	0	0	0	0	0	0	0
Tertiary		0	0	0	0	0	0	0	0	0

Final Type	Final Score
W2	1

High (>10%)

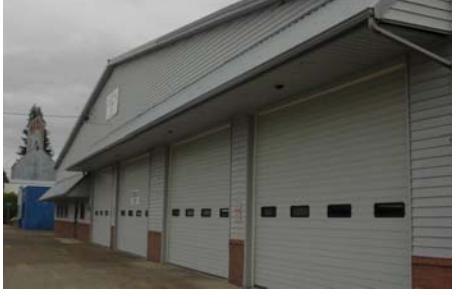
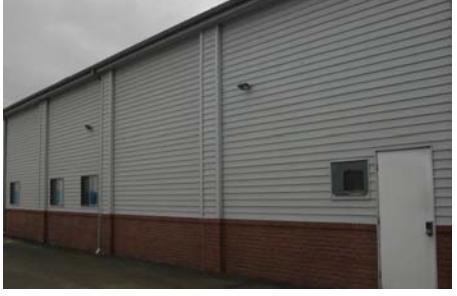
W	Plan Irregularity Primary	E	General Site

Enrollment	Year Built (Field Verified)	Year Built (Alt. Source)	Est. Decade Built
	1974	1974	1970
Total Area (square ft)	Number of Stories	Basement	Pounding Potential
	1	No	No
Plan Irregularities		Vertical Irregularities	
Torsion: Eccentric Stiffness		Steps in Elevation View: Single Change	
None		None	
None		None	
Falling Hazards		Poor Conditions	
None		None	
None		None	
None		None
