Harrisburg Fire & Rescue - Station 41

Linn_fir06A

FEMA 154 Rapid Visual Screening Score Card

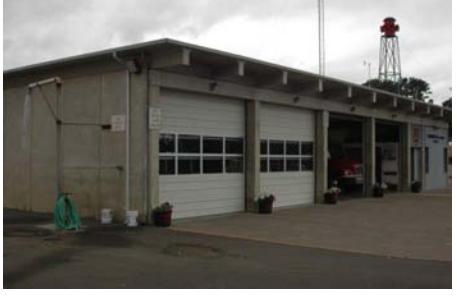
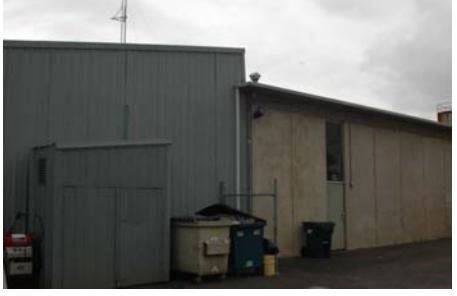
NE Plan Irregularity Secondary		E Vertical Irregularity Primary

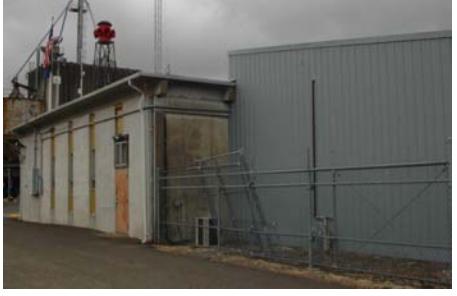
W Plan Irregularity Primary S3 addition shown
