# Tangent RFPD

Linn\_fir08A

## FEMA 154 Rapid Visual Screening Score Card

Rapid Visual Screening - Senate Bill #2 - Seismic Needs Assessment  
Oregon Department of Geology and Mineral Industries

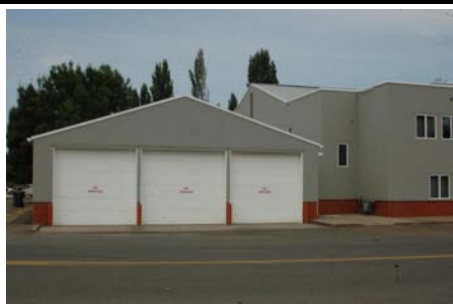
S Vertical Irregularity Primary  
torsion - eccentric stiffness

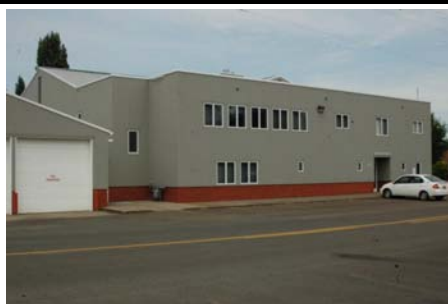
S Plan Irregularity Primary
