Linn_fir21A

Building Type		County	
Fire - RFPD		Linn	
Street			
39023 SE 2nd Ave			
City	State	Zip	
Scio	OR	97374	
Latitude		Longitude	
44.70332		122.84693	
Tracking Code		Inspection Date	
RVS in 2006		6/30/2006

FEMA 154 Rapid Visual Screening Score Card

Linn_fir21B

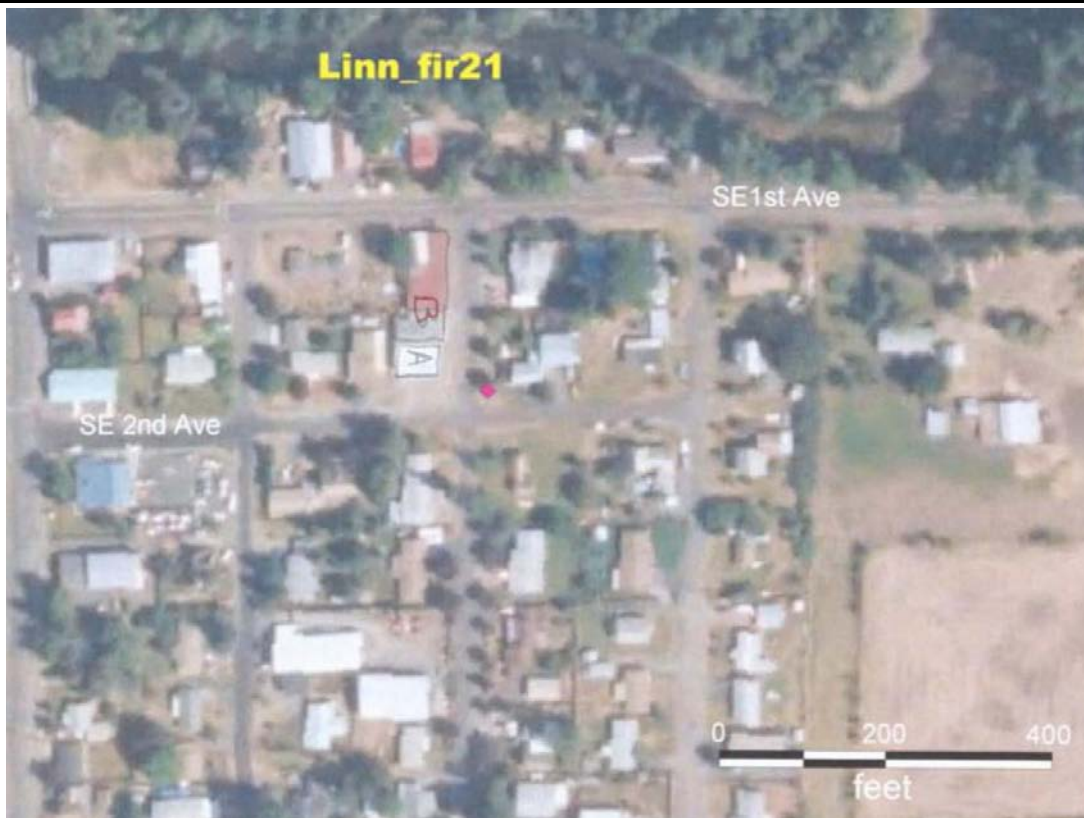
Type	Basic Score	Vert Irreg	Plan Irreg	Pre-Code	Post-Bench	Soil C	Soil D	Soil E	RVS Score
Primary	S3	3.8	0	0	0	0	0	-1	0	2.8
Secondary		0	0	0	0	0	0	0	0	0
Tertiary		0	0	0	0	0	0	0	0	0

Low (<1%)

Plan Irregularities	Vertical Irregularities
Reentrant Corners: Other (Adjacent Build/Entity)	Steps in Elevation View: Single Change
Reentrant Corners: Other	None
None	None

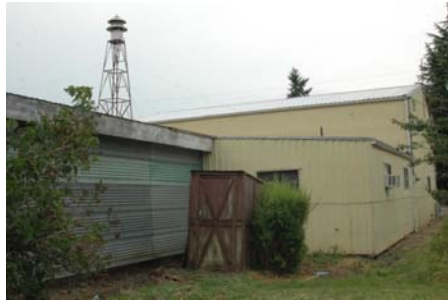
W Vertical Irregularity Primary

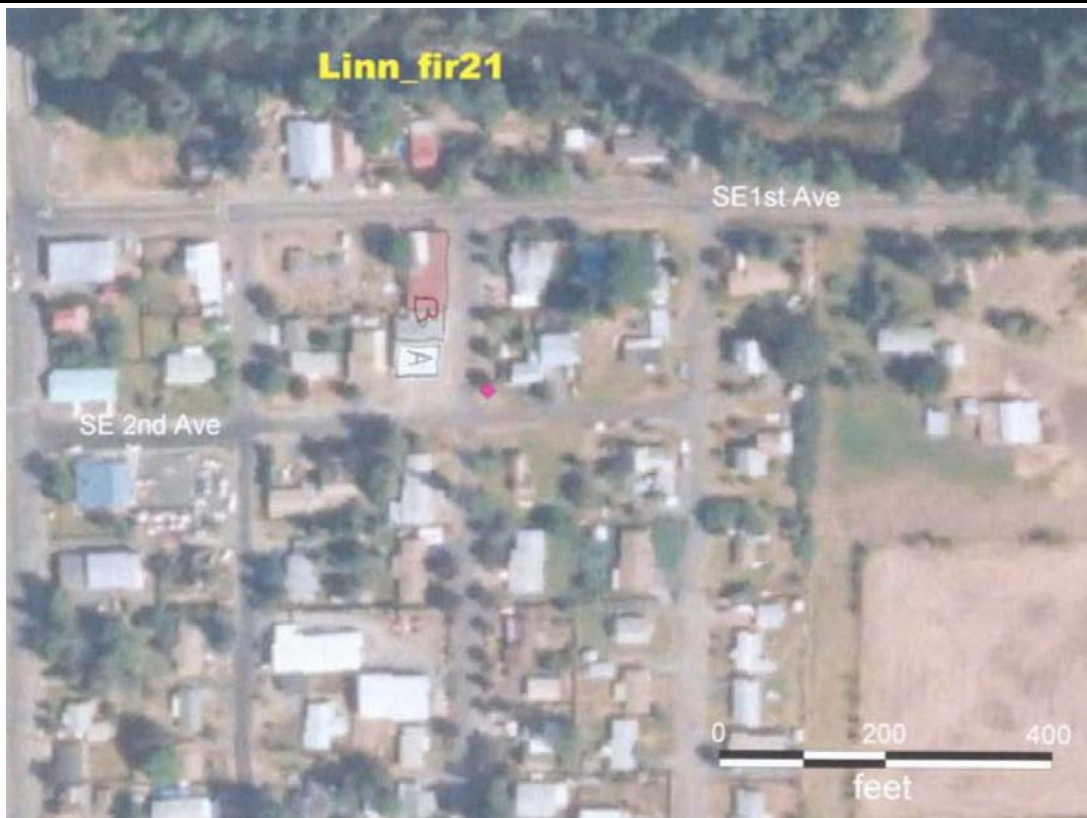
Type	Basic Score	Vert Irreg	Plan Irreg	Pre-Code	Post-Bench	Soil C	Soil D	Soil E	RVS Score
Primary	S3	3.8	0	-0.5	0	0	0	-1	0	2.3
Secondary		0	0	0	0	0	0	0	0	0
Tertiary		0	0	0	0	0	0	0	0	0

Low (<1%)

Plan Irregularities	Vertical Irregularities
Reentrant Corners:Other (Adjacent Build/Entity)	Steps in Elevation View: Single Change (Adjacent Building/Entity)
Torsion: Eccentric Stiffness	None
None	None
