# Scio RFPD

## FEMA 154 Rapid Visual Screening Score Card

Rapid Visual Screening - Senate Bill #2 - Seismic Needs Assessment  
Oregon Department of Geology and Mineral Industries

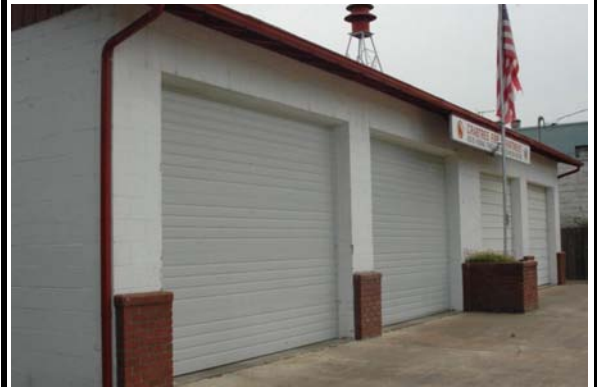
Seismicity Zone: Moderate

Type	Basic Score	Vert Irreg	Plan Irreg	Pre-Code	Post-Bench	Soil C	Soil D	Soil E	RVS Score
Primary	RM1	3.6	0	-0.5	0	0	0	-1.2	0	1.9
Secondary		0	0	0	0	0	0	0	0	0
Tertiary		0	0	0	0	0	0	0	0	0

1.9

Moderate (>1%)
