Jefferson RFPD

Linn\_fir27A

## FEMA 154 Rapid Visual Screening Score Card

Rapid Visual Screening - Senate Bill #2 - Seismic Needs Assessment  
Oregon Department of Geology and Mineral Industries

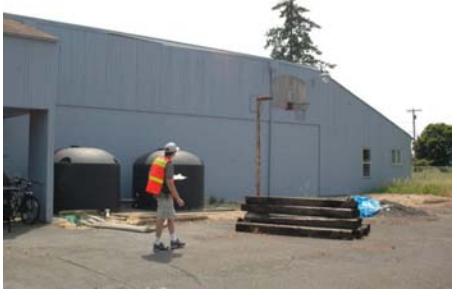
| W General Site<br>This picture shows a large CMU wall on the opposite side of the large door openings. | | | |
