Samaritan Albany General Hospital

Linn_hos01A

FEMA 154 Rapid Visual Screening Score Card

Rapid Visual Screening - Senate Bill #2 - Seismic Needs Assessment
Oregon Department of Geology and Mineral Industries

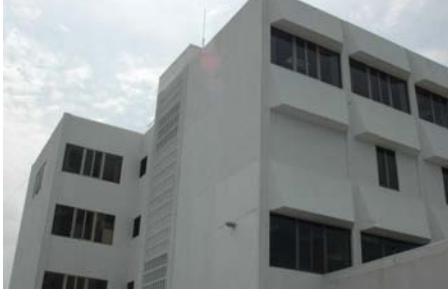
NE	General Site	N	Primary Structural Type Also Cladding (solid concrete awnings) ..I beam -shaped pieces.

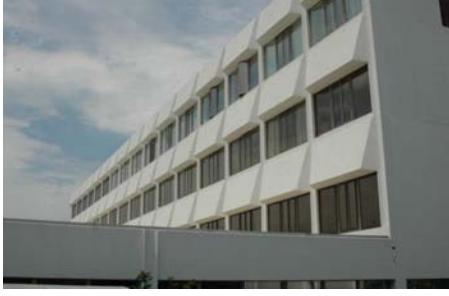
E	Vertical Irregularity Primary
