# Samaritan Lebanon Community Hospital

Linn\_hos02A

Building Type Hospital	County Linn	
Street 525 N Santiam Hwy		
City Lebanon	State OR	Zip 97355
Latitude 44.55097	Longitude 122.90713	
Tracking Code New Building	Inspection Date 7/31/2006

Rapid Visual Screening - Senate Bill #2 - Seismic Needs Assessment  
Oregon Department of Geology and Mineral Industries

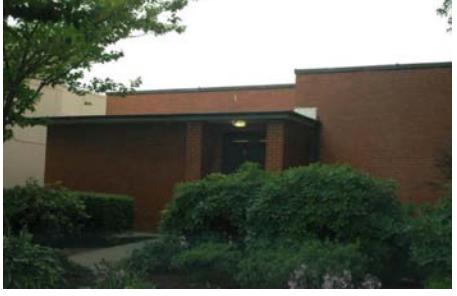
N General Site

Enrollment	Year Built (Field Verified)	Year Built (Alt. Source)	Est. Decade Built
	1951	1951	1950
Total Area (square ft)	Number of Stories	Basement	Pounding Potential
	1	No	No
Plan Irregularities		Vertical Irregularities	
Reentrant Corners:Other (Adjacent Build/Entity)		Steps in Elevation View: 2 to 3 Changes (Adjacent Building/Entity)	
Reentrant Corners: Other		None	
Reentrant Corners: Other (Adjacent Build/Entity)		None	
Falling Hazards		Poor Conditions	
None		None	
None		None	
None		None

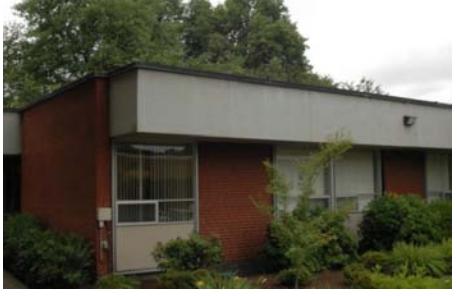
E General Site

Enrollment	Year Built (Field Verified)	Year Built (Alt. Source)	Est. Decade Built
	1960	1951	1960
Total Area (square ft)	Number of Stories	Basement	Pounding Potential
	1	No	No
Plan Irregularities		Vertical Irregularities	
Reentrant Corners: U shaped		Steps in Elevation View: 2 to 3 Changes (Adjacent Building/Entity)	
Reentrant Corners: Other (Adjacent Build/Entity)		None	
None		None	
Falling Hazards		Poor Conditions	
None		None	
None		None	
None		None

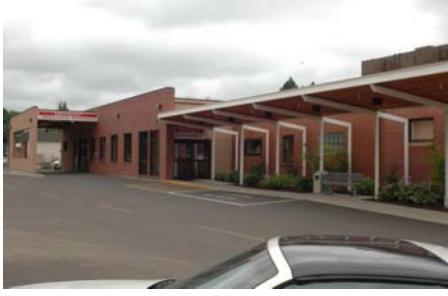
Enrollment	Year Built (Field Verified)	Year Built (Alt. Source)	Est. Decade Built
	1961	1951	1960
Total Area (square ft)	Number of Stories	Basement	Pounding Potential
	1	No	No
Plan Irregularities		Vertical Irregularities	
Reentrant Corners: Other		Steps in Elevation View: 2 to 3 Changes (Adjacent Building/Entity)	
Reentrant Corners: Other (Adjacent Build/Entity)		None	
None		None	
Falling Hazards		Poor Conditions	
None		None	
None		None	
None		None

N General Site Also shows building A.

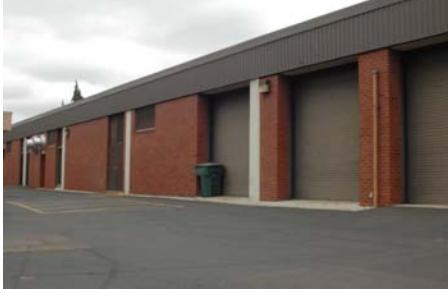
N General Site

Enrollment	Year Built (Field Verified)	Year Built (Alt. Source)	Est. Decade Built
	1988	1951	1980
Total Area (square ft)	Number of Stories	Basement	Pounding Potential
	1	No	No
Plan Irregularities		Vertical Irregularities	
Reentrant Corners:Other (Adjacent Build/Entity)		Steps in Elevation View: Single Change (Adjacent Building/Entity)	
None		None	
None		None	
Falling Hazards		Poor Conditions	
None		None	
None		None	
None		None
