| 354 Smith St. | | |

FEMA 154 Rapid Visual Screening Score Card

Linn County Sheriff's Office

Rapid Visual Screening - Senate Bill #2 - Seismic Needs Assessment
Oregon Department of Geology and Mineral Industries

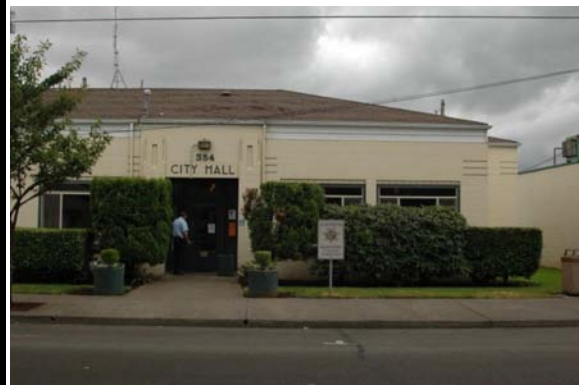
| | Type | Basic Score | Vert Irreg | Plan Irreg | Pre-Code | Post-Bench | Soil C | Soil D | Soil E | RVS Score |
|---|---|---|---|---|---|---|---|---|---|---|
| Primary | C2 | 2.8 | 0 | -0.5 | -1 | 0 | 0 | -0.6 | 0 | 0.7 |

High (>10%)

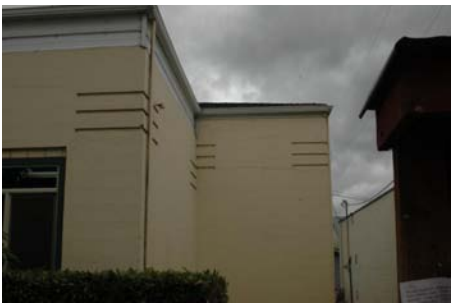
NE Plan Irregularity Primary

| Reentrant Corners: Other | None |
