Albany Police Department

Linn_pol10A

FEMA 154 Rapid Visual Screening Score Card

Rapid Visual Screening - Senate Bill #2 - Seismic Needs Assessment
Oregon Department of Geology and Mineral Industries

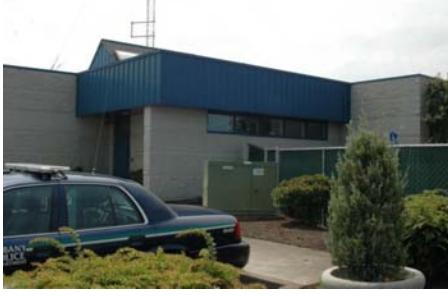
NW Plan Irregularity Primary
