Harrisburg Elementary School

Harrisburg SD 7J

FEMA 154 Rapid Visual Screening Score Card

Rapid Visual Screening - Senate Bill #2 - Seismic Needs Assessment
Oregon Department of Geology and Mineral Industries

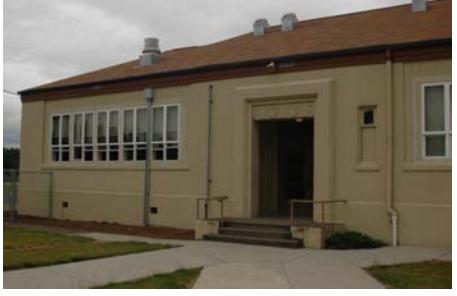
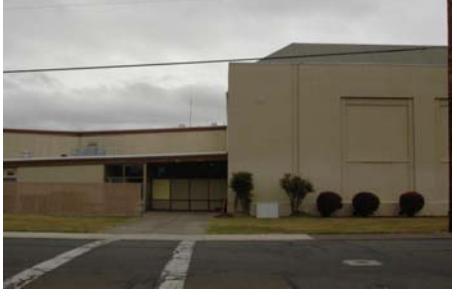
S Primary Structural Type		W Vertical Irregularity Primary	W Vertical Irregularity Primary

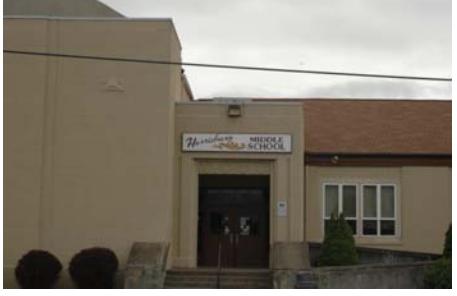
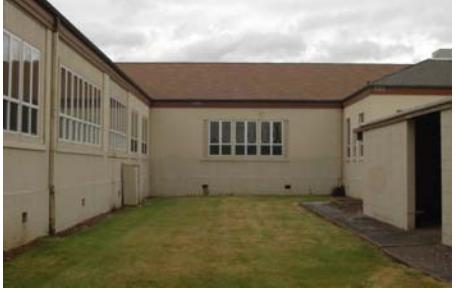
E Plan Irregularity Primary

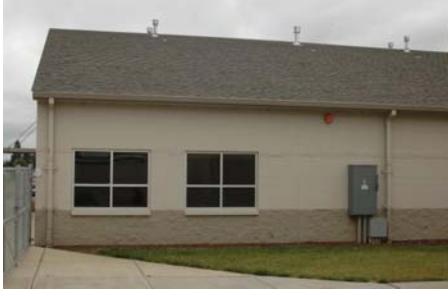
NE General Site

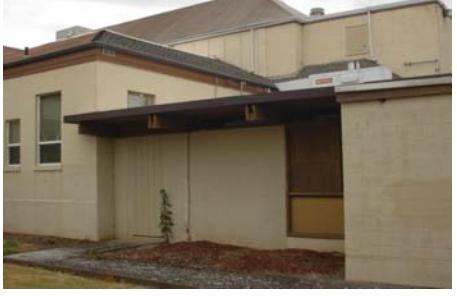
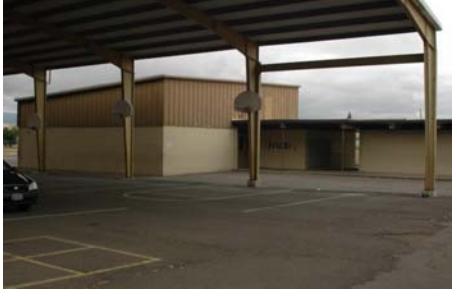
S Primary Structural Type		N Plan Irregularity Primary Also shows covered playground.

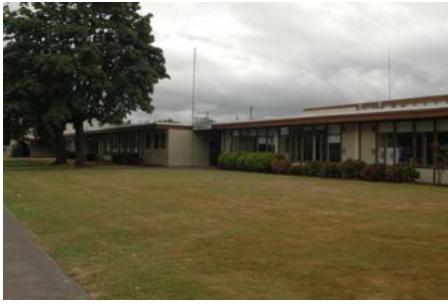
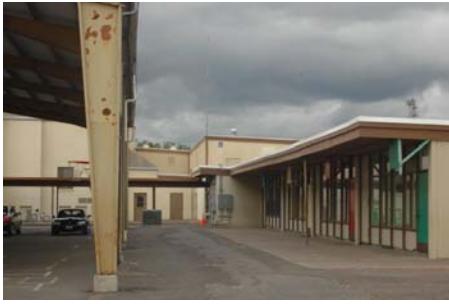
N Plan Irregularity Primary		E Vertical Irregularity Primary
