Foster Elementary School

Sweet Home SD 55

Linn_sch15A

Rapid Visual Screening - Senate Bill #2 - Seismic Needs Assessment
Oregon Department of Geology and Mineral Industries

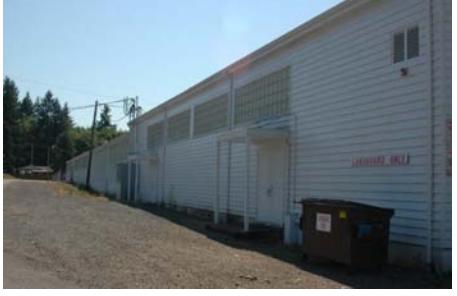
| NE General Site | NW Plan Irregularity Secondary | W Plan Irregularity Primary | |

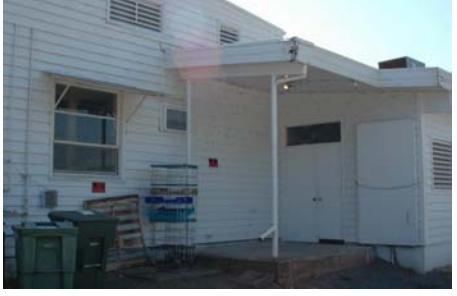
| Plan Irregularities Reentrant Corners: U shaped Reentrant Corners: Other None | | Vertical Irregularities Steps in Elevation View: Single Change None None | |

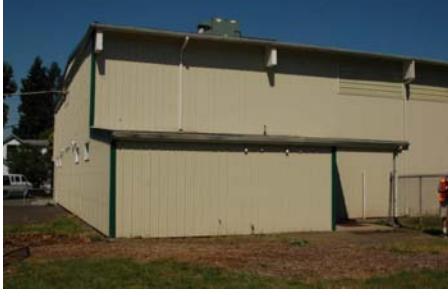
| SE General Site Small mechanical room ignored. (seen in foreground) | | | |
