# Scio High School

Linn\_sch23A

## FEMA 154 Rapid Visual Screening Score Card

Rapid Visual Screening - Senate Bill #2 - Seismic Needs Assessment  
Oregon Department of Geology and Mineral Industries

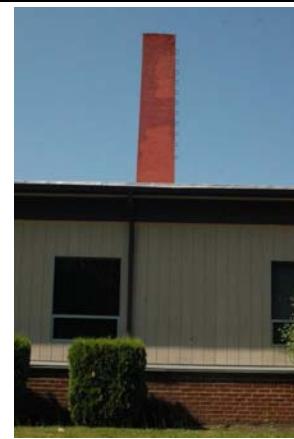
Final Type	Final Score
RM1	-0.1

Very High (100%)

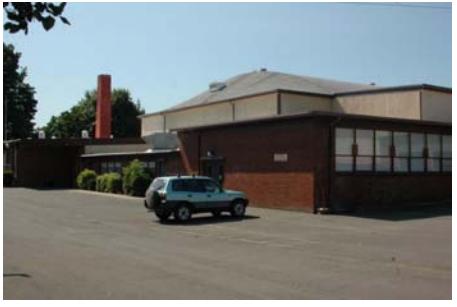
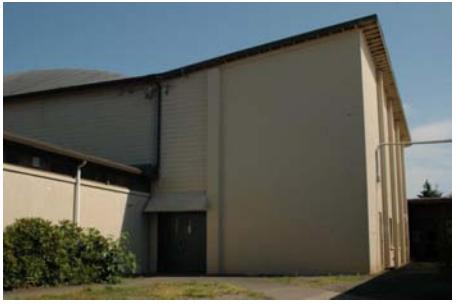
S Vertical Irregularity Primary reentrant corner		W Plan Irregularity Primary GYM - dual system (RM1 + W2) elevation step

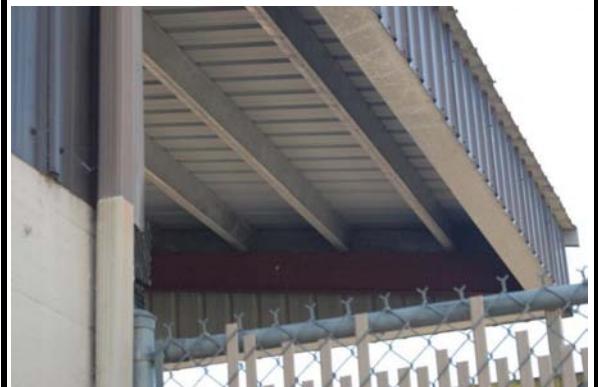
Linn\_sch23B

Final Type	Final Score
RM1	2.4

Low (<1%)

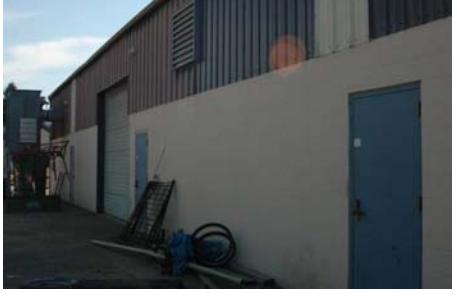
N Primary Structural Type

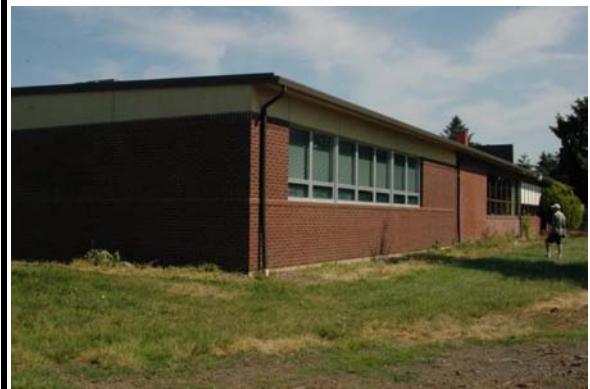
Linn\_sch23C

Final Type	Final Score
RM1	1.9

Moderate (>1%)

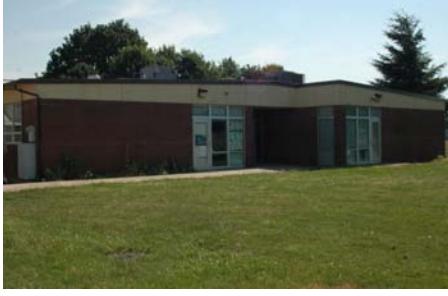
N Plan Irregularity Primary
