Central Linn High School

Linn_sch27A

FEMA 154 Rapid Visual Screening Score Card

Rapid Visual Screening - Senate Bill #2 - Seismic Needs Assessment
Oregon Department of Geology and Mineral Industries

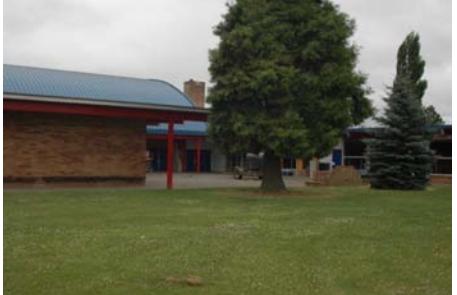
W Other glu-lam arch that appears to cover the area of two basketball courts.

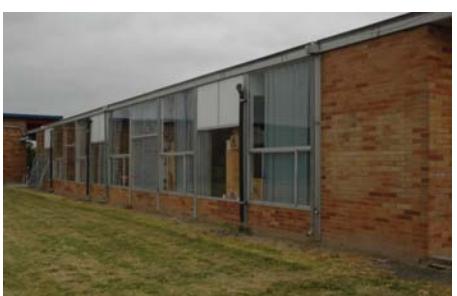
W Other Buttress for glu-lam arch. This is one of the few that are exposed to the exterior. We suspect that the rest land into the main part of the school (n)

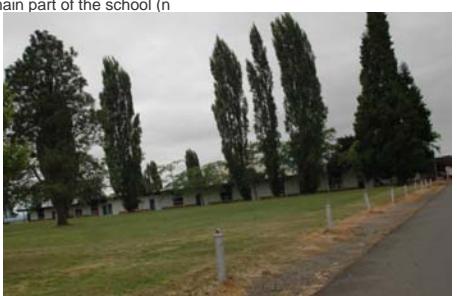
NE Primary Structural Type Other than small masonry end (single course) this wall has wood columns and a lot of glass. Many similar places around school.

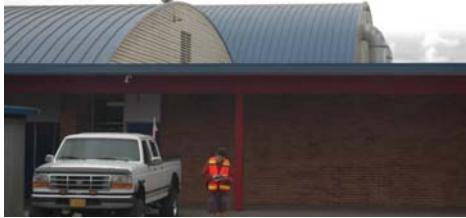
S General Site Arched area over gym is hidden by trees.

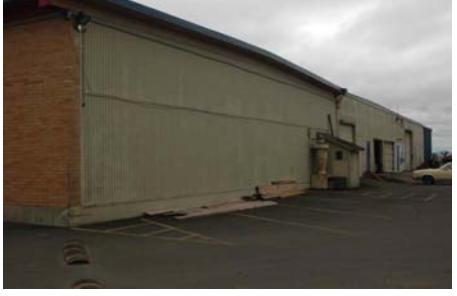
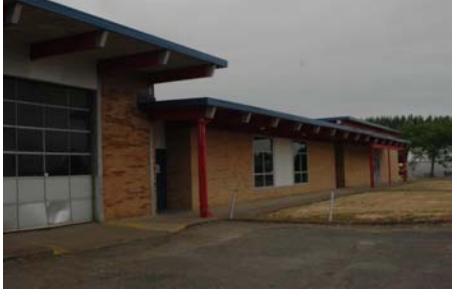
NW Primary Structural Type Brick, wood, and at the far right end light metal.		S Vertical Irregularity Primary
