# Harrisburg High School

Linn\_sch29A

## FEMA 154 Rapid Visual Screening Score Card

Rapid Visual Screening - Senate Bill #2 - Seismic Needs Assessment  
Oregon Department of Geology and Mineral Industries

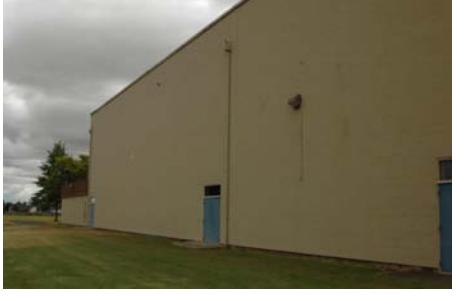
W Vertical Irregularity Primary shorter section on left	NE Plan Irregularity Primary	E General Site
