# Central Linn Elementary School

Linn\_sch30A

## FEMA 154 Rapid Visual Screening Score Card

Rapid Visual Screening - Senate Bill #2 - Seismic Needs Assessment  
Oregon Department of Geology and Mineral Industries

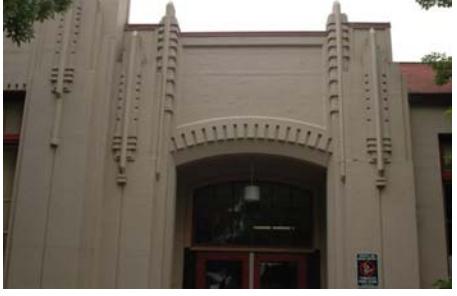
E Primary Structural Type out of plane lateral system		NW Primary Structural Type

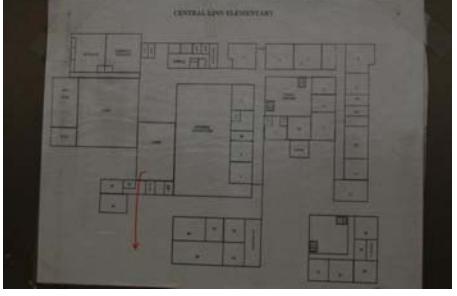
E Plan Irregularity Primary plan of building

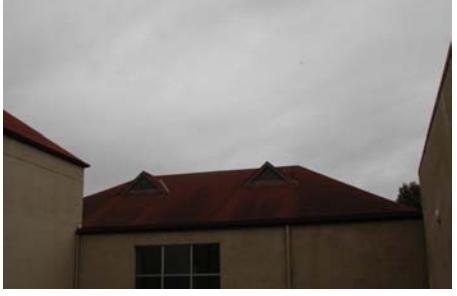
NE Vertical Irregularity Primary	W Vertical Irregularity Primary	E General Site
