Harrisburg Middle School

Harrisburg SD 7J

FEMA 154 Rapid Visual Screening Score Card

Rapid Visual Screening - Senate Bill #2 - Seismic Needs Assessment
Oregon Department of Geology and Mineral Industries

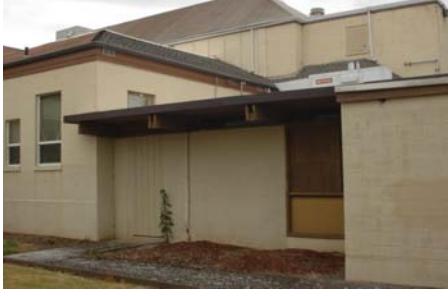
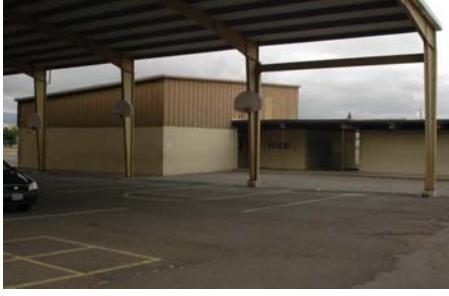
S Vertical Irregularity Primary		N Plan Irregularity Primary also shows the covered play ground. Step in elevation

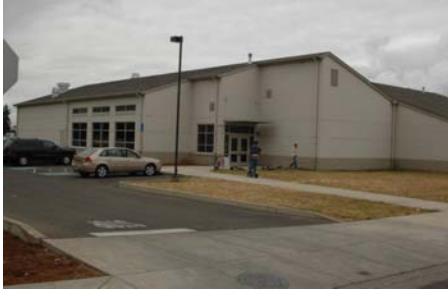
SE Plan Irregularity Primary

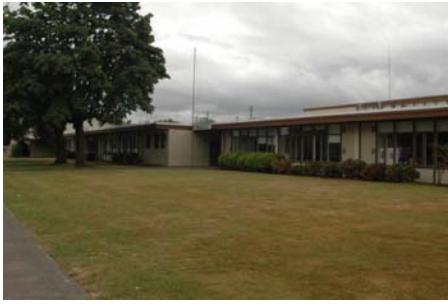
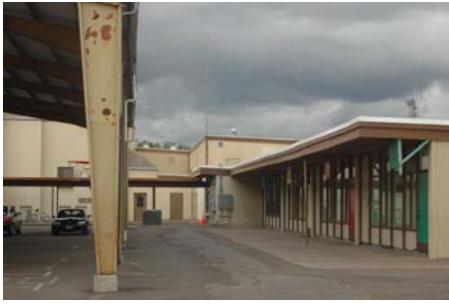
N Plan Irregularity Primary		E Vertical Irregularity Primary
