# Scio Middle School

| RVS in 2006 | | 6/30/2006 | |

## FEMA 154 Rapid Visual Screening Score Card

Rapid Visual Screening - Senate Bill #2 - Seismic Needs Assessment  
Oregon Department of Geology and Mineral Industries

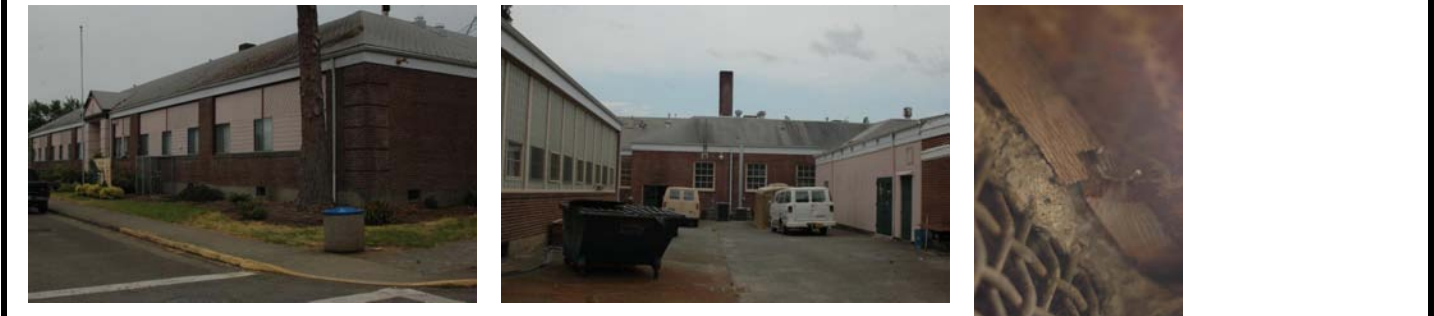
W    General Site

E    Falling Hazard  
Also shows inside of 'U'

W    Primary Structural Type  
Close up from foundation vent. From right to left, metal angle holding brick veneer, the wood tounge and groove. This wood led to the W2 designation.
