Mari-Linn Elementary School

North Santiam SD 29J

FEMA 154 Rapid Visual Screening Score Card

Rapid Visual Screening - Senate Bill #2 - Seismic Needs Assessment
Oregon Department of Geology and Mineral Industries

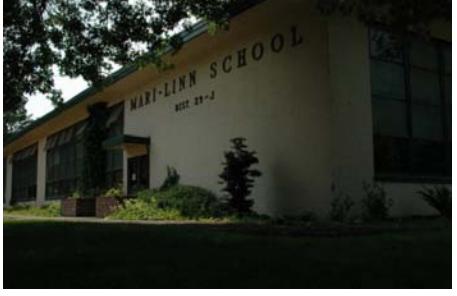
NE General Site	S Primary Structural Type

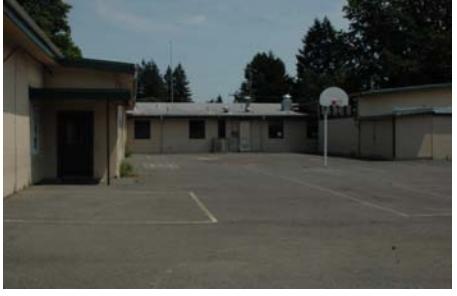
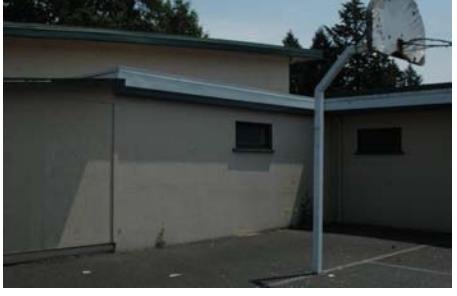
W Vertical Irregularity Primary	NW Primary Structural Type

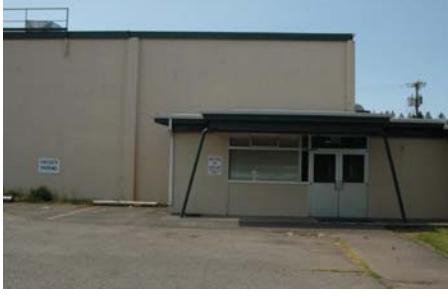
E Vertical Irregularity Primary reentrant corner
