Nyssa City Police Dept

City of Nyssa

FEMA 154 Rapid Visual Screening Score Card

Rapid Visual Screening - Senate Bill #2 - Seismic Needs Assessment
Oregon Department of Geology and Mineral Industries

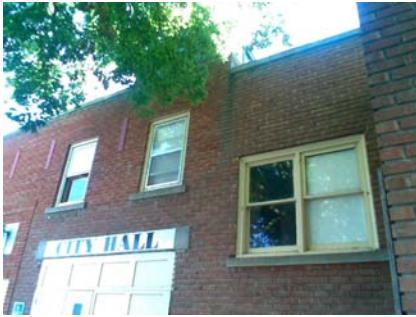
W	Vertical Irregularity Primary

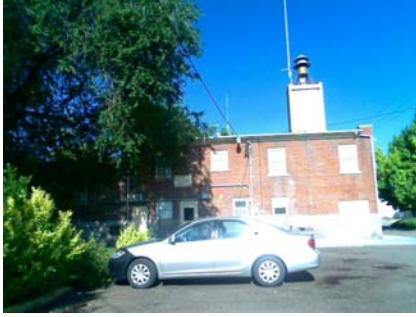
E	Falling Hazard
