May Roberts Elementary School

Malh_sch02A

FEMA 154 Rapid Visual Screening Score Card

Rapid Visual Screening - Senate Bill #2 - Seismic Needs Assessment
Oregon Department of Geology and Mineral Industries

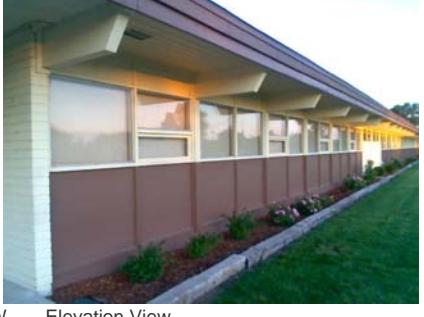
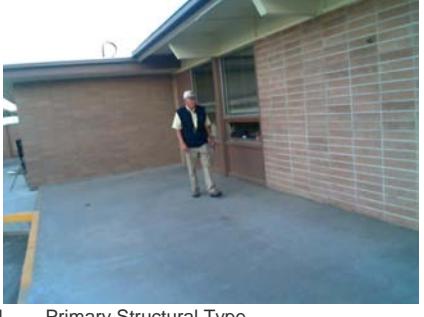
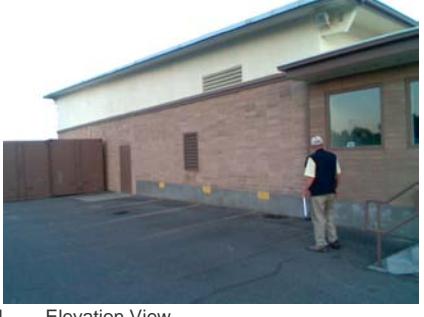
Enrollment 365	Year Built (Field Verified) 1970	Year Built (Alt. Source) 1970	Est. Decade Built 1960
Total Area (square ft) 33653	Number of Stories 1	Basement	Pounding Potential No
Plan Irregularities Reentrant Corners: L Shaped None None		Vertical Irregularities Steps in Elevation View: Single Change None None	
Falling Hazards None None None		Poor Conditions None None None

W Elevation View	N Primary Structural Type	N Elevation View gym

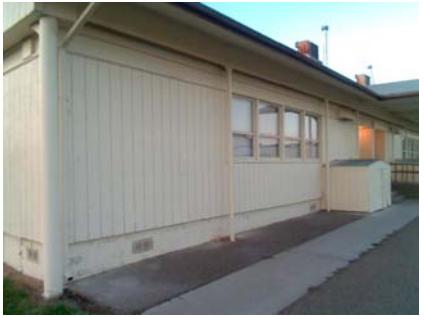
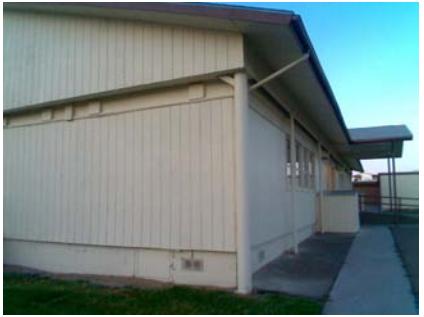
Enrollment 365	Year Built (Field Verified) 1970	Year Built (Alt. Source) 1970	Est. Decade Built 1950
Total Area (square ft) 33653	Number of Stories 1	Basement	Pounding Potential No
Plan Irregularities None None None		Vertical Irregularities None None None	
Falling Hazards None None None		Poor Conditions None None None

S Elevation View		W Seismic Upgrade
