# Ontario Middle School

Malh\_sch04A

| RVS in 2006 | | 6/30/2006 | |

Rapid Visual Screening - Senate Bill #2 - Seismic Needs Assessment  
Oregon Department of Geology and Mineral Industries

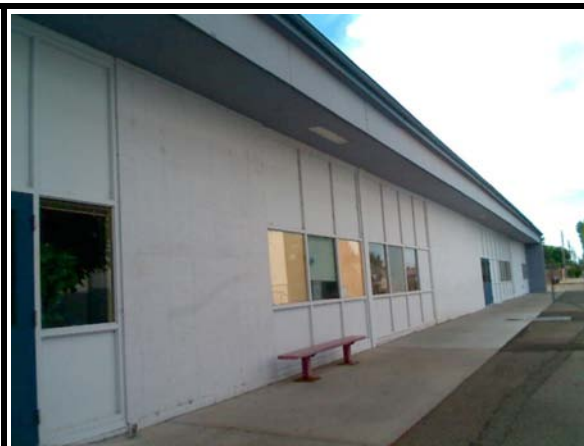
| | Type | Basic Score | Vert Irreg | Plan Irreg | Pre-Code | Post-Bench | Soil C | Soil D | Soil E | RVS Score |
|---|---|---|---|---|---|---|---|---|---|---|
| Primary | RM1 | 3.6 | 0 | 0 | 0 | 0 | 0 | -1.2 | 0 | 2.4 |

Low (<1%)

| Other: Brick Veneer | None |

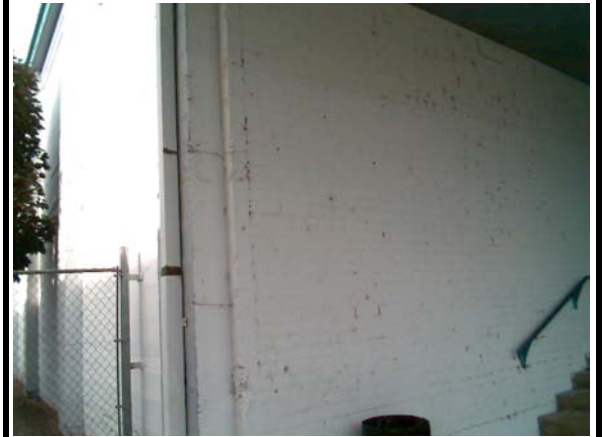
| | Type | Basic Score | Vert Irreg | Plan Irreg | Pre-Code | Post-Bench | Soil C | Soil D | Soil E | RVS Score |
|---|---|---|---|---|---|---|---|---|---|---|
| Primary | C2 | 3.6 | -2 | 0 | 0 | 0 | 0 | -1.2 | 0 | 0.4 |

High (>10%)

| None | Steps in Elevation View: Single Change |

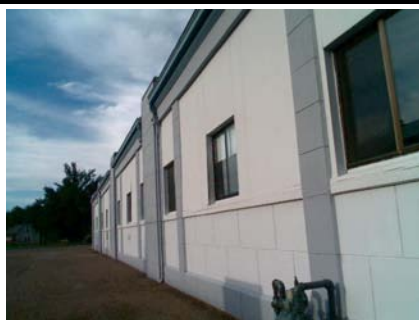
W Elevation View

| Out of Plane Lateral-Force-Resistance Elements | None |
| Reentrant Corners: L Shaped | None |

| Parapets: Unreinforced Across Front of Building | None |

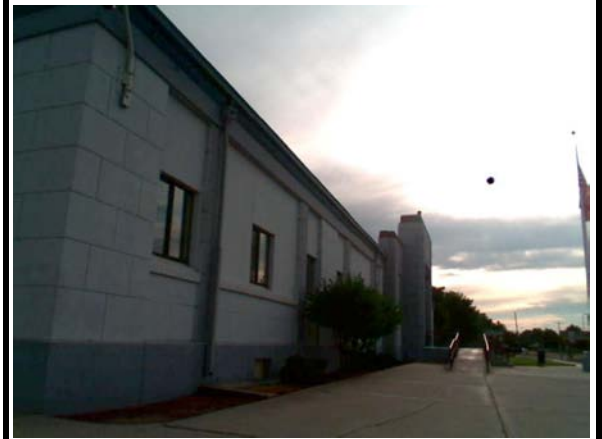
| | Type | Basic Score | Vert Irreg | Plan Irreg | Pre-Code | Post-Bench | Soil C | Soil D | Soil E | RVS Score |
|---|---|---|---|---|---|---|---|---|---|---|
| Primary | RM1 | 3.6 | -2 | 0 | 0 | 0 | 0 | -1.2 | 0 | 0.4 |

High (>10%)

| None | Steps in Elevation View: Single Change |

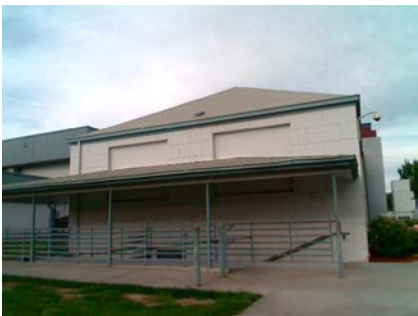
W Elevation View

| Parapets: Unreinforced Across Front of Building | None |
