Ontario High School

Malh_sch05A

FEMA 154 Rapid Visual Screening Score Card

Rapid Visual Screening - Senate Bill #2 - Seismic Needs Assessment
Oregon Department of Geology and Mineral Industries

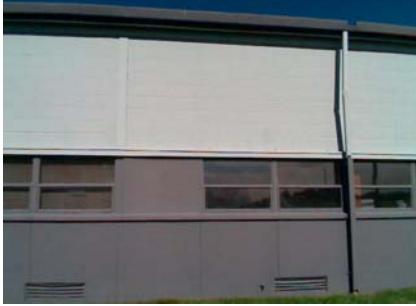
W Primary Structural Type

Enrollment 784	Year Built (Field Verified) 1980	Year Built (Alt. Source) 1980	Est. Decade Built 1950
Total Area (square ft) 87681	Number of Stories 1	Basement	Pounding Potential No
Plan Irregularities Reentrant Corners: E Shaped None None		Vertical Irregularities Steps in Elevation View: Single Change None None	
Falling Hazards None None None		Poor Conditions None None None

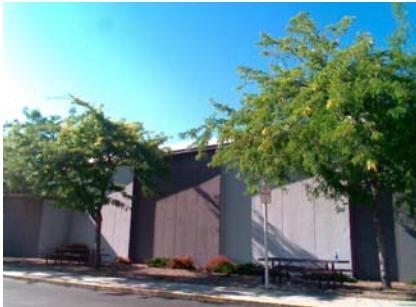
S Elevation View

Enrollment 784	Year Built (Field Verified) 1980	Year Built (Alt. Source) 1980	Est. Decade Built 1970
Total Area (square ft) 87681	Number of Stories 1	Basement	Pounding Potential Yes
Plan Irregularities Reentrant Corners:L shaped (Adjacent Build/Entity) None None		Vertical Irregularities Steps in Elevation View: Single Change (Adjacent Building/Entity) None None	
Falling Hazards None None None		Poor Conditions None None None

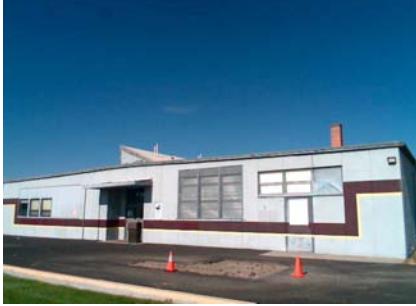
W Elevation View

Enrollment 784	Year Built (Field Verified) 1980	Year Built (Alt. Source) 1980	Est. Decade Built 1970
Total Area (square ft) 87681	Number of Stories 1	Basement	Pounding Potential No
Plan Irregularities Reentrant Corners:L shaped (Adjacent Build/Entity) None None		Vertical Irregularities Steps in Elevation View: Single Change (Adjacent Building/Entity) None None	
Falling Hazards Other: Smokestack None None		Poor Conditions None None None
