Vale Elementary School

Vale SD 84

FEMA 154 Rapid Visual Screening Score Card

Rapid Visual Screening - Senate Bill #2 - Seismic Needs Assessment
Oregon Department of Geology and Mineral Industries

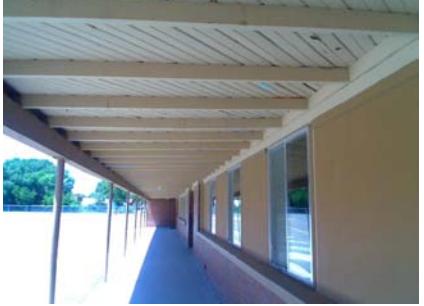
| Plan Irregularities Reentrant Corners: U shaped Reentrant Corners: L Shaped (Adjacent Build/Entity) None | | Vertical Irregularities Steps in Elevation View: Single Change None None | |
| S Primary Structural Type | | S Primary Structural Type | |

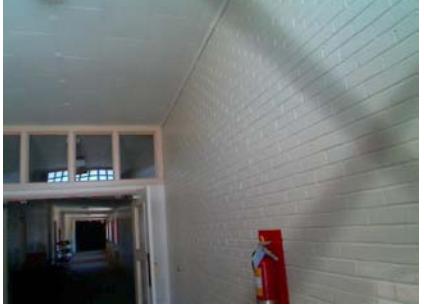
| | | S Primary Structural Type urn wall | |

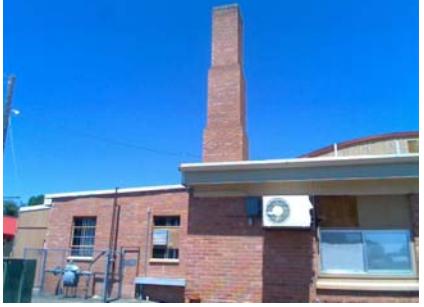
| Falling Hazards Other: Smokestack Other: General Other: Brick Veneer | | Poor Conditions None None None | |
| S Falling Hazard | | | |

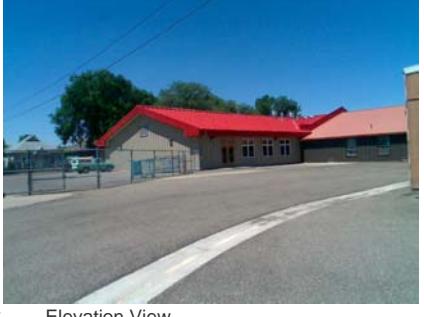
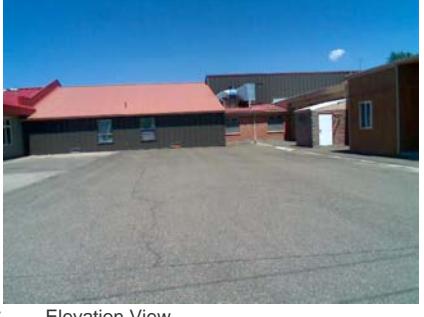
| S Elevation View | | S Elevation View | |

| Plan Irregularities Reentrant Corners:L shaped (Adjacent Build/Entity) None None | | Vertical Irregularities None None None | |
| Falling Hazards Other: Brick Veneer None None | | Poor Conditions None None None | |

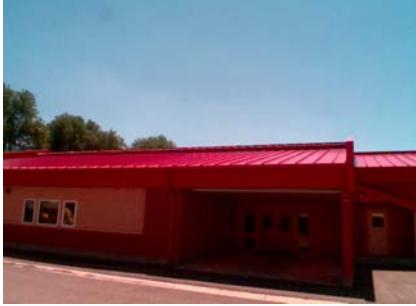
| N Elevation View | | | |

| Plan Irregularities Reentrant Corners: L Shaped None None | | Vertical Irregularities None None None | |
