Nyssa High School

Malh_sch09A

Building Type School	County Malheur	
Street 824 Adrian Blvd		
City Nyssa	State OR	Zip 97913
Latitude 43.87456	Longitude 117.00564	
Tracking Code RVS in 2006	Inspection Date 6/30/2006

Rapid Visual Screening - Senate Bill #2 - Seismic Needs Assessment
Oregon Department of Geology and Mineral Industries

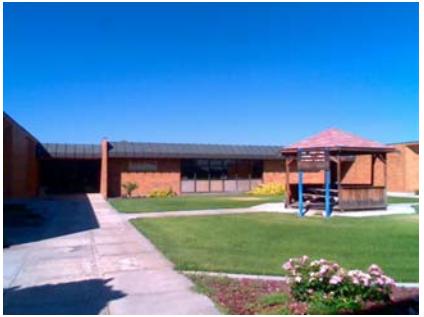
N Elevation View

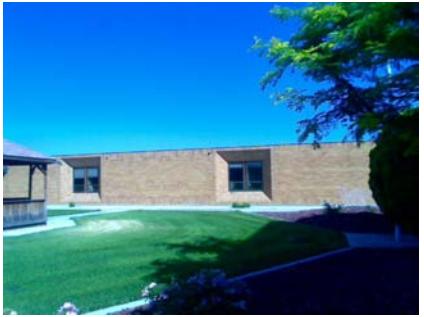
E Elevation View

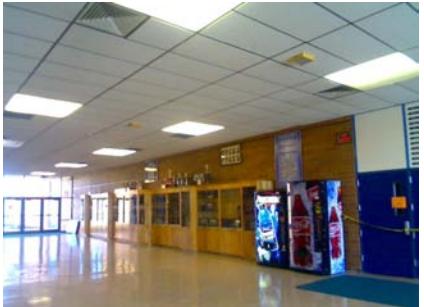
S Primary Structural Type inside

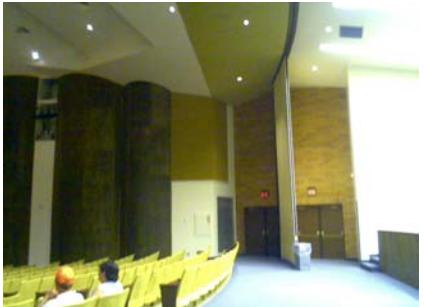
S Primary Structural Type inside aud
