Vale High School

Malh_sch11A

FEMA 154 Rapid Visual Screening Score Card

Rapid Visual Screening - Senate Bill #2 - Seismic Needs Assessment
Oregon Department of Geology and Mineral Industries

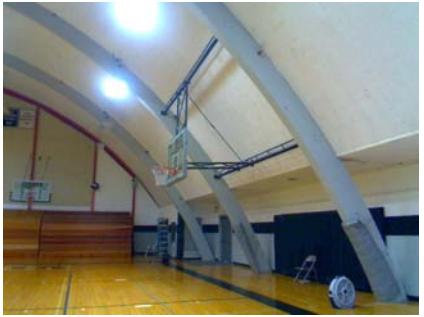
S Primary Structural Type inside gym wood structure		S Elevation View
