Technical Skills (#005)

Chemeketa CC

FEMA 154 Rapid Visual Screening Score Card

Rapid Visual Screening - Senate Bill #2 - Seismic Needs Assessment
Oregon Department of Geology and Mineral Industries

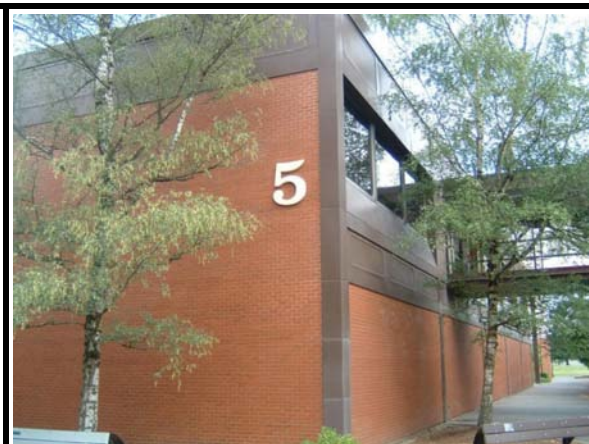
Seismicity Zone: High

| | Type | Basic Score | Vert Irreg | Plan Irreg | Pre-Code | Post-Bench | Soil C | Soil D | Soil E | RVS Score |
|---|---|---|---|---|---|---|---|---|---|---|
| Primary | RM1 | 2.8 | -1 | -0.5 | 0 | 0 | 0 | -0.6 | 0 | 0.7 |

0.7

High (>10%)
