Aurora RFPD

Mari_fir01A

FEMA 154 Rapid Visual Screening Score Card

Rapid Visual Screening - Senate Bill #2 - Seismic Needs Assessment
Oregon Department of Geology and Mineral Industries

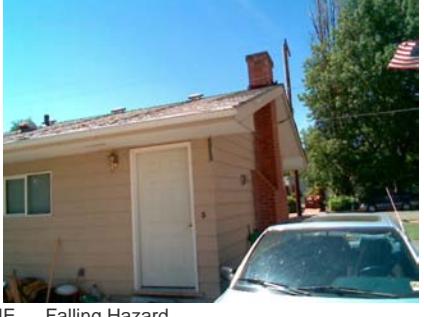
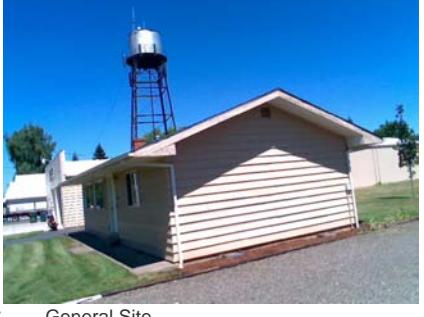
Enrollment	Year Built (Field Verified)	Year Built (Alt. Source)	Est. Decade Built
			1960
Total Area (square ft)	Number of Stories	Basement	Pounding Potential
	1	No	No
Plan Irregularities		Vertical Irregularities	
None		None	
None		None	
None		None	
Falling Hazards		Poor Conditions	
Unreinforced Chimneys		None	
None		None	
None		None

NE Falling Hazard
