Aurora RFPD

Mari_fir06A

Building Type	County	
Fire - RFPD	Marion	
Street		
20909 Feller St		
City	State	Zip
Donald	OR	97020
Latitude	Longitude	
45.2218	122.84108	
Tracking Code	Inspection Date	
RVS in 2006	7/26/2006

FEMA 154 Rapid Visual Screening Score Card

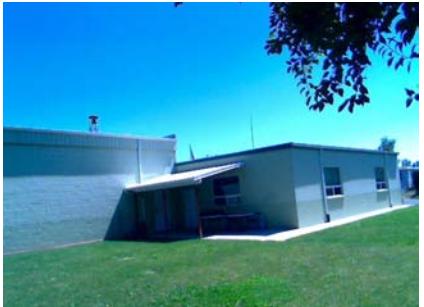
NW Plan Irregularity Primary

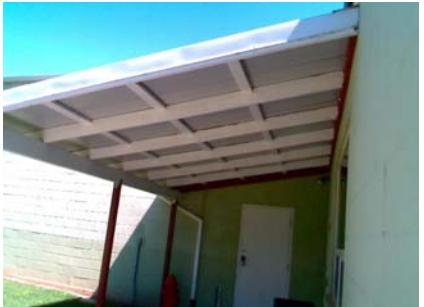
SW Falling Hazard

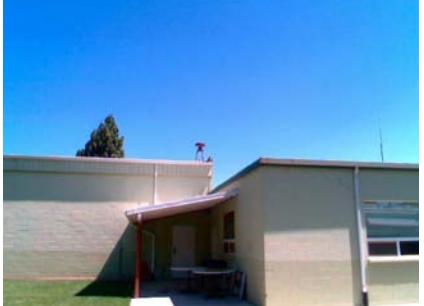
W Vertical Irregularity Primary

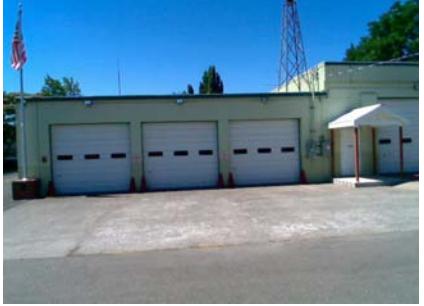
E Primary Structural Type

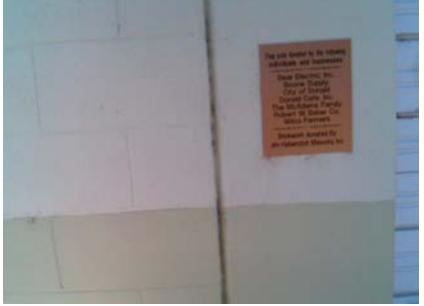
E Secondary Structural Type		
<p>columns on these bays are cast in place concrete, along with the beam above the doors.</p> <p>The rest is RM1</p>		<p>columns on left bay are cast in place concrete, the beam above the doors is also Concrete</p>
