Marion County Fire District 1 - Garage - Building 2

Marion County Fire District 1

Building Type Fire - RFPD	County Marion
Street 300 Cordon Rd NE	
City Salem	State OR
Zip 97301	
Latitude 44.93193	Longitude 122.95849
Tracking Code RVS in 2006	Inspection Date 8/3/2006

Rapid Visual Screening - Senate Bill #2 - Seismic Needs Assessment
Oregon Department of Geology and Mineral Industries

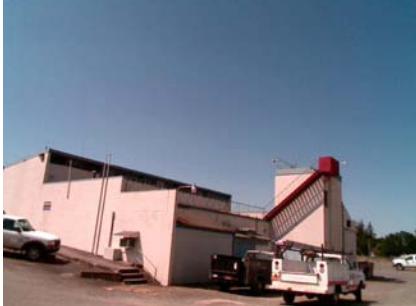
SE Vertical Irregularity Primary	NE General Site	NE Plan Irregularity Primary

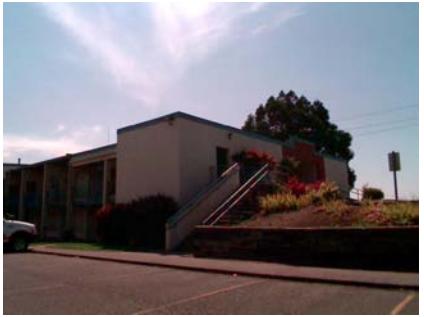
NE Vertical Irregularity Primary		NW Elevation View

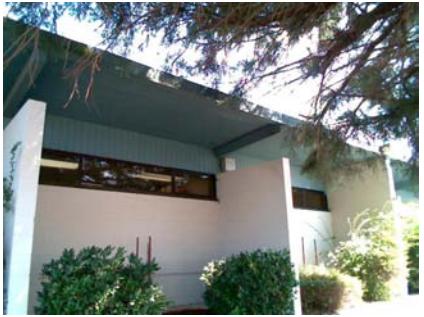
W Vertical Irregularity Secondary

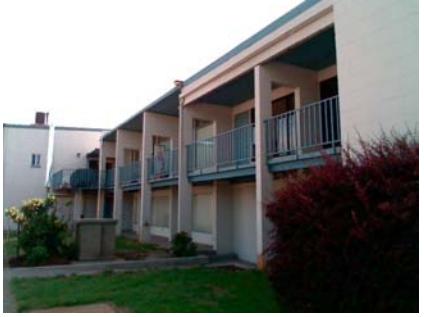
E Falling Hazard CMU BALCONIES
