Salem Fire Dept - Station 06

Mari_fir10A

FEMA 154 Rapid Visual Screening Score Card

Rapid Visual Screening - Senate Bill #2 - Seismic Needs Assessment
Oregon Department of Geology and Mineral Industries

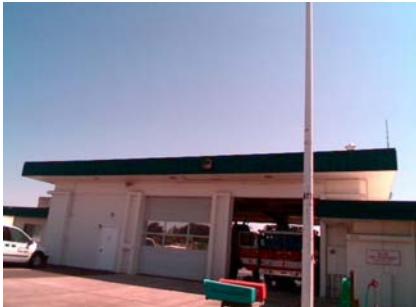
W Vertical Irregularity Secondary		W Plan Irregularity Secondary

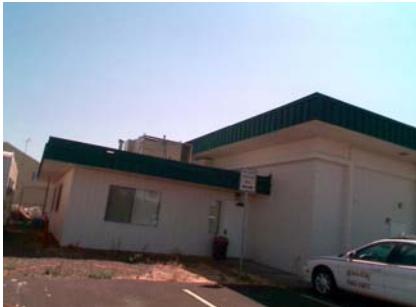
NW Plan Irregularity Primary SMALL WOOD FRAMED ADDITION ON N SIDE OF STATION
