# Stayton RFPD

Mari\_fir14A

| Tracking Code<br>RVS in 2006 | Inspection Date<br>7/18/2006 | |

## FEMA 154 Rapid Visual Screening Score Card

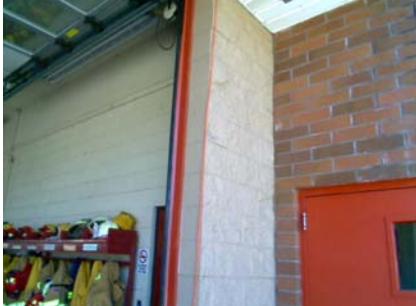
| N | Primary Structural Type | NE | Vertical Irregularity Primary |

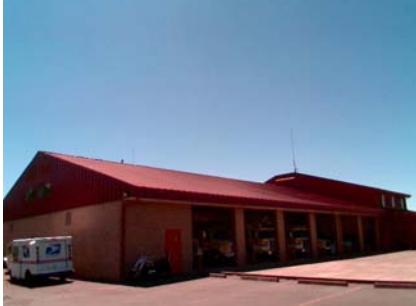
| Reentrant Corners: Other | | Steps in Elevation View: 2 to 3 Changes | |

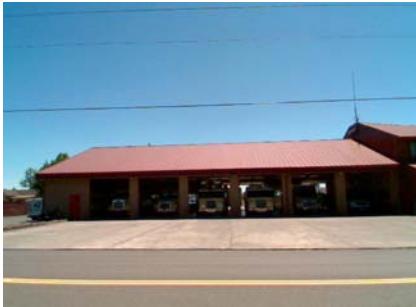
| SW | Plan Irregularity Primary | SW | General Site |

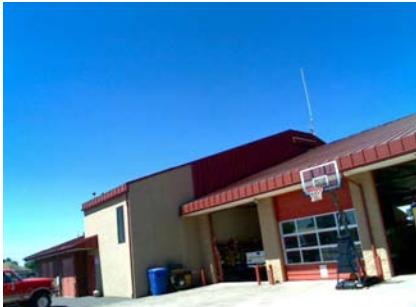
| SW | Plan Irregularity Secondary | NW | General Site |
