Hubbard RFPD

Building Type Fire - RFPD	County Marion	
Street 3161 2nd St		
City Hubbard	State OR	Zip 97032
Latitude 45.17974	Longitude 122.80952	
Tracking Code RVS in 2006	Inspection Date 7/26/2006

FEMA 154 Rapid Visual Screening Score Card

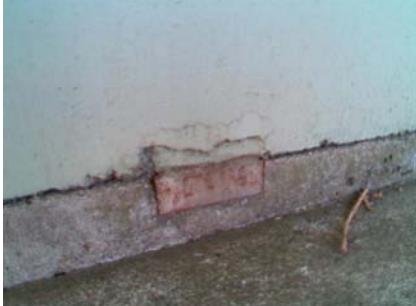
N Primary Structural Type welded joint at base of tilt up.

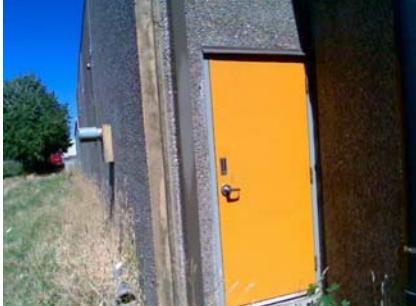
SW Primary Structural Type caulked joint
