Salem Fire Dept - Station 07

Mari_fir18A

FEMA 154 Rapid Visual Screening Score Card

Rapid Visual Screening - Senate Bill #2 - Seismic Needs Assessment
Oregon Department of Geology and Mineral Industries

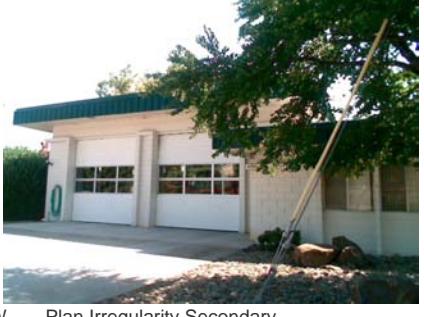
W	Plan Irregularity Secondary	SW	Vertical Irregularity Primary

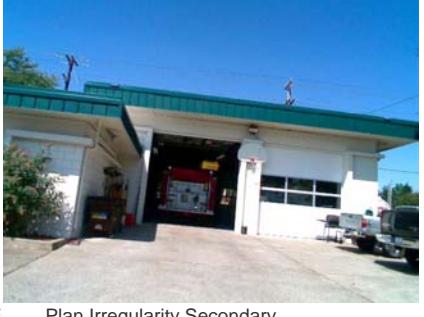
NW	Elevation View	SE	Vertical Irregularity Secondary

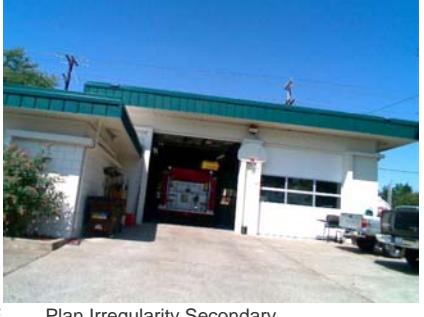
E	Plan Irregularity Secondary
