Stayton RFPD

Building Type Fire - RFPD	County Marion	
Street 5898 Stayton Rd		
City Turner	State OR	Zip 97392
Latitude 44.75032	Longitude 122.94015	
Tracking Code RVS in 2006	Inspection Date 8/3/2006

## FEMA 154 Rapid Visual Screening Score Card

Rapid Visual Screening - Senate Bill #2 - Seismic Needs Assessment  
Oregon Department of Geology and Mineral Industries

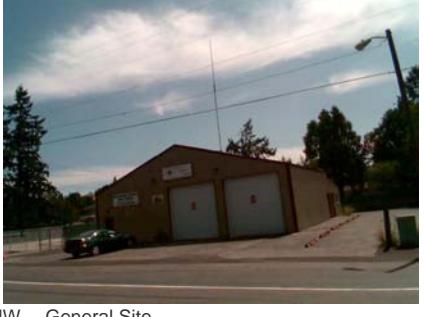
NW General Site		SW Elevation View
