# Woodburn RFPD Waconda Station Office

Building Type Fire - RFPD	County Marion	
Street 11484 River Rd		
City Gervais	State OR	Zip 97026
Latitude 45.08572	Longitude 122.97599	
Tracking Code RVS in 2006	Inspection Date 7/28/2006

Rapid Visual Screening - Senate Bill #2 - Seismic Needs Assessment  
Oregon Department of Geology and Mineral Industries

# Woodburn RFPD Waconda Station Garage

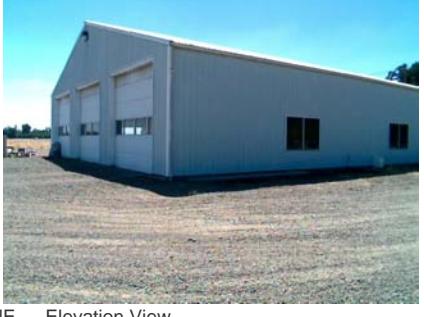
E General Site
<p>W Primary Structural Type THIS BUILDING IS A POLE BARN - STRUCTURE TYPE IS ALSO DESCRIBED ON WEBSITE</p>
